TO ASSESS THE IMPACT OF LANDUSE CHANGE ON NUTRIENTS FLOW AND TO ESTABLISH THE LEVEL OF KEY POLLUTANTS OF NYANGORES RIVER

F. K. Kigira¹ and P. G. Home² and J. M. Gathenya

This study was carried out with the aim of assessing the effect of riparian land use/ land cover change on the hydrology and water quality of the upper Mara River catchment specifically Nyangores River. The study incorporated remote sensing and GIS tools to prepare and analyze the data. It involved sampling of sediments deposits and water flows at various points of the river to quantify water quality parameters such as N, P, Ca and Fe. These parameters were tested in the laboratory.

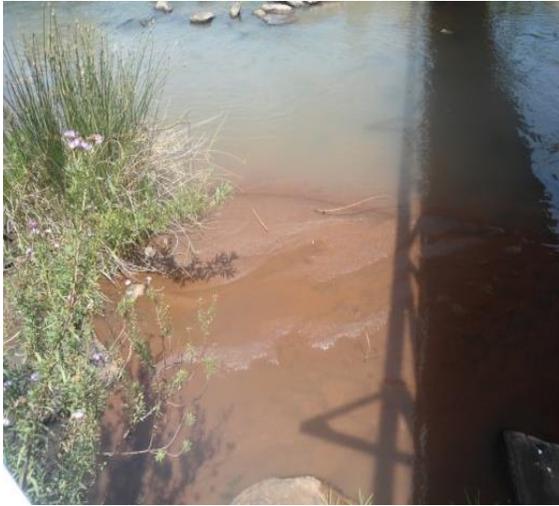
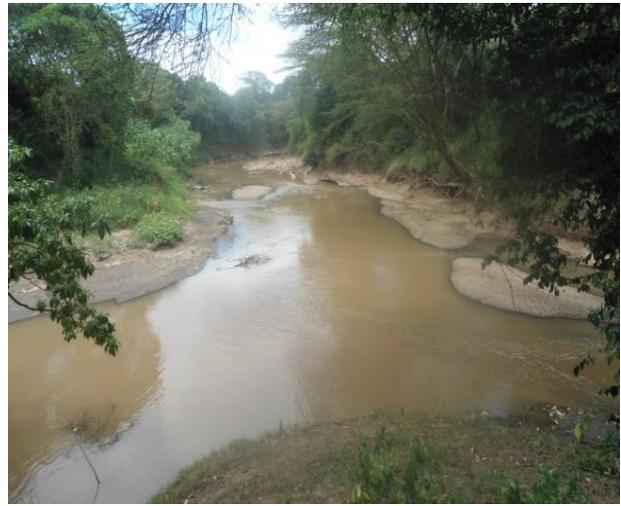
Figure.3.1: Shows lower Nyangores River heavily loaded with sediment

Digital image analysis for the riparian zone showed that between 1976 and 2003, crop land increased by about 100%, other vegetation and forests have reduced by 32% and 34% respectively with the river line decreasing by 50%. There is a continued decrease in the river line caused by declining quantity of water as a result of increased sediment in the river this is evident with figure 3.1 which shows accumulation of the sediment in the lower Nyangores River. The progressive increase in cropland and declining river line as shown in table 3.1 suggest that much of the natural riparian vegetation has been destroyed leading to sediment flow into the river.

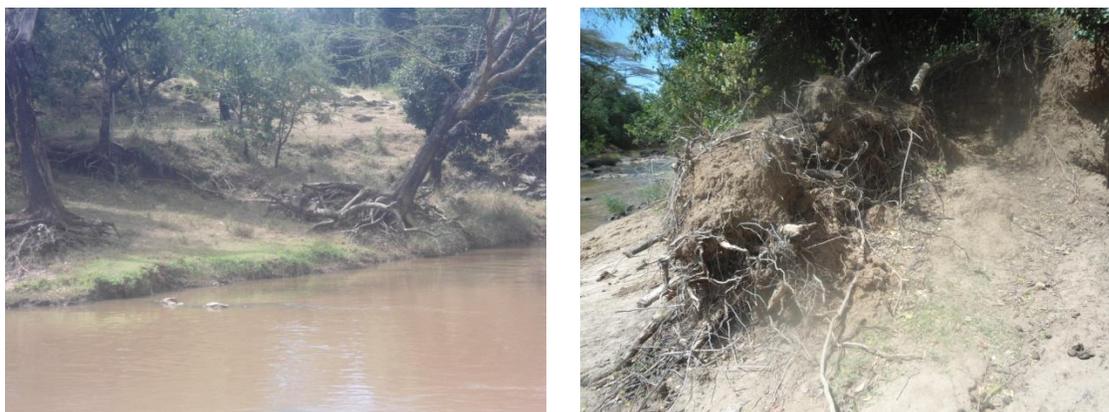
Figure 3.3: River banks of lower Nyangores River where trees have exposed roots caused by washing away of the poorly cohesive sandy soil.

At the river bank elevation 1714m, S00°59'417, E035015'634 existence of exposed tree roots was observed which is a sign of bank erosion. Table 3.4 Shows Soil collected at this point and tested for particle size analysis using hydrometer method and showed the following characteristics.

Sandy soils has a poor cohesion and they are therefore prone to erosion and hence the appearance of uprooted trees and exposed tree roots at this part of Nyangores river which has lead to lose of riparian vegetation as shown in figure 3.3 below.

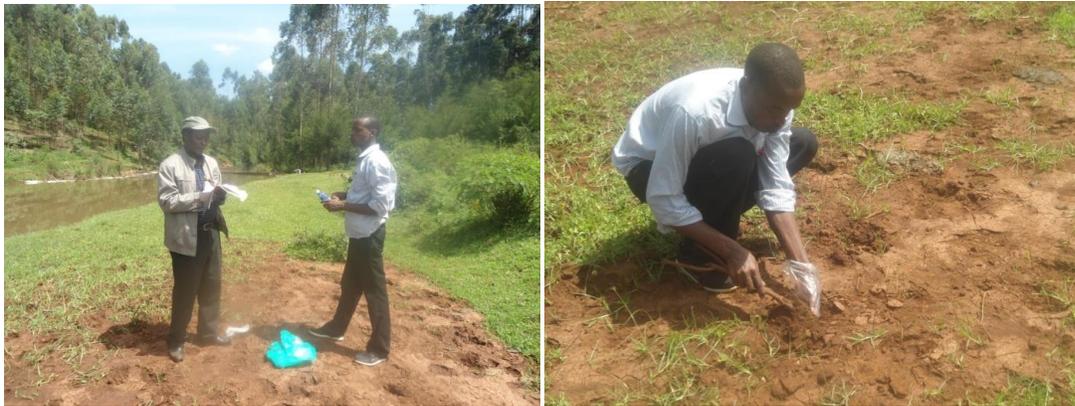
Figure3.4: Shows sampling of soil sediments trapped by Kikuyu Grass along the river bank.

Table.3.2 shows the values of Ph, EC, N, P, K, Ca, %TOC, and Fe of soil deposit obtained from the river bed as well as the bank of River Nyangores. Location 3 and 4 represents a cattle track which is intercepted by a well protected river bank growing with Kikuyu grass as shown in figure 3.4 shown below. The soil shows a high Ph value of 5.4. P= 0.66, N=0.7, 6.4 %TOC and Fe=17mg/kg .This could be attributed to the channelization leading to urban areas as well as animal faeces. The Kikuyu Grass has a high trapping efficiency. Quarrying activities at location 7 as shown

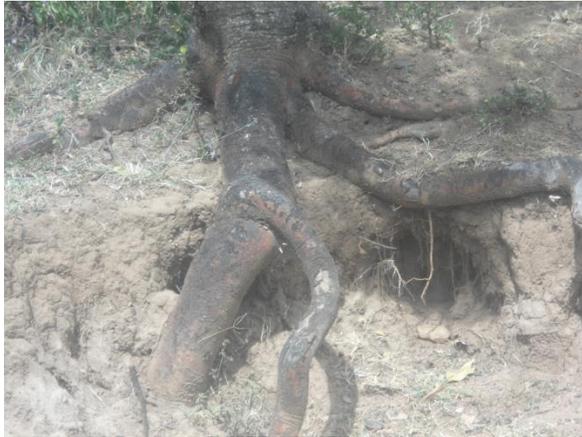
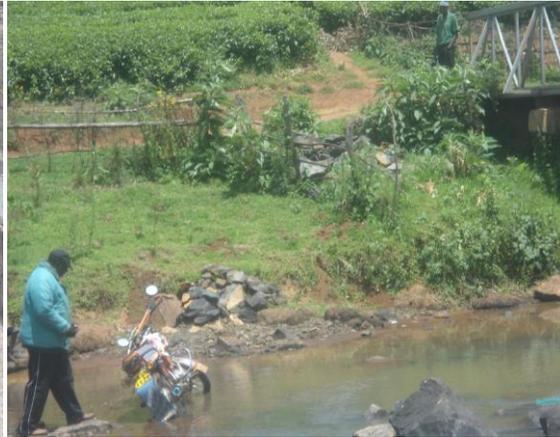
Profile of a large woody tree within the Mara River Watershed illustrates the intricate root system that works to stabilize soil. Cleaning of vehicles is also observed (Photo by F. Kigira)

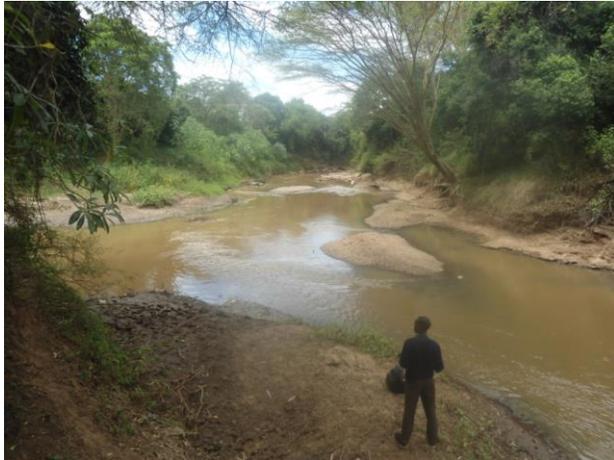
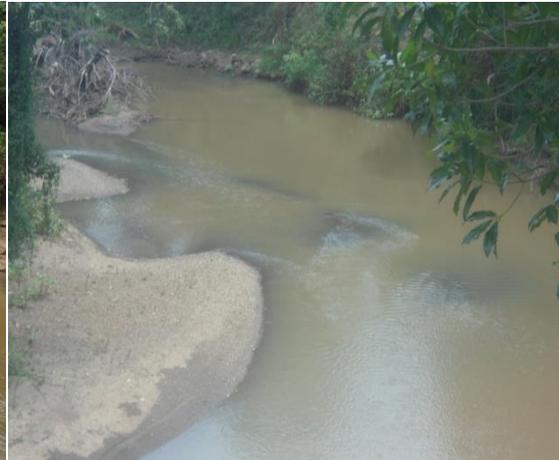
Sediment deposit downstream of Nyangores River reducing the River capacity

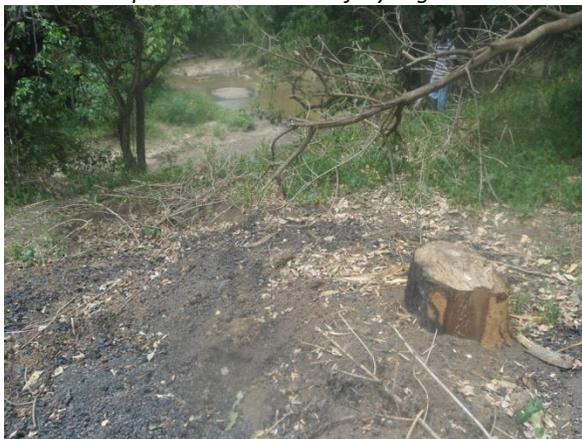
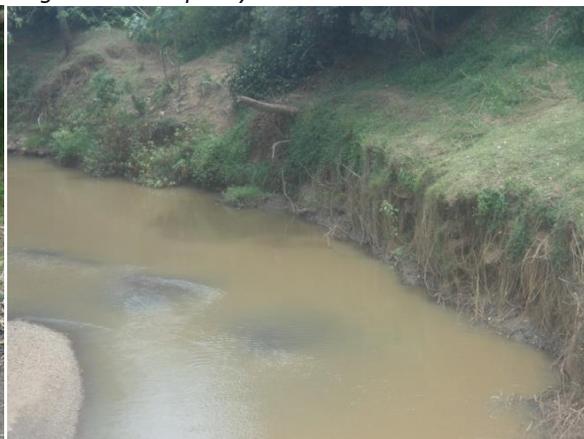
Burning of charcoal and destruction of river banks by livestock

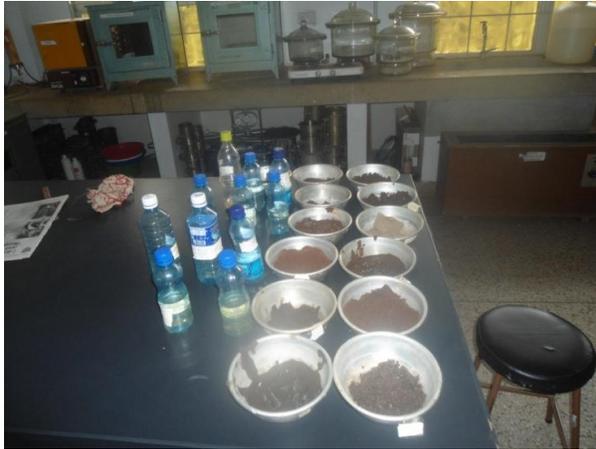
Soil and water samples in the laboratory ready for analysis

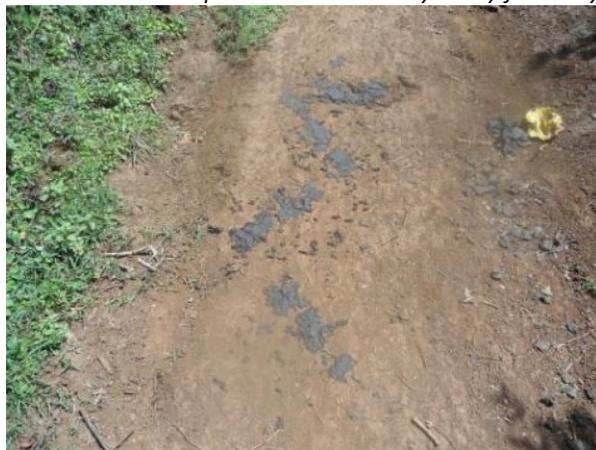
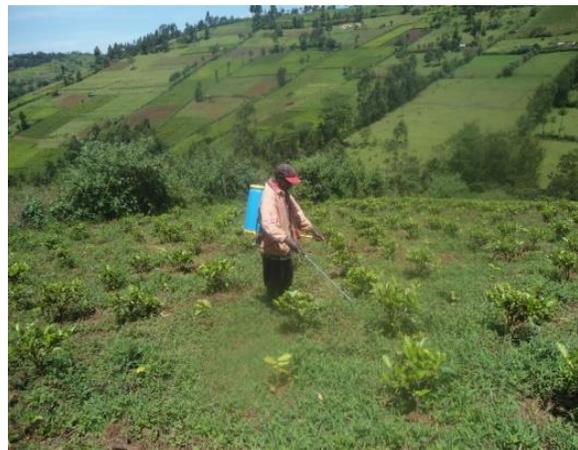
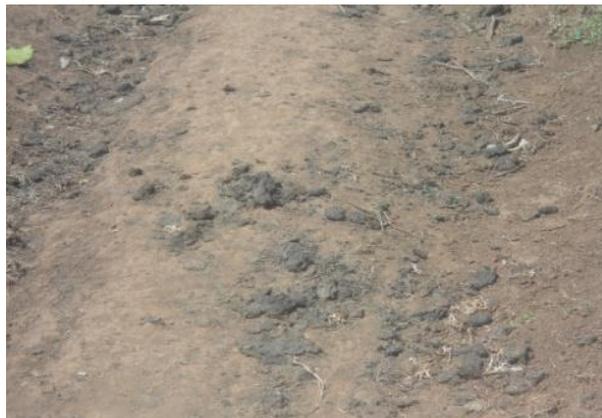
Animal waste and chemical application in agricultural activities also contributes to decline in river water quality
