**CRACKING OF JOINTED PLAIN CONCRETE  
PAVEMENT: A CASE STUDY OF KAGERE- NDUNYU-  
MUNYANGE- GITUIGA (E571) ROAD IN OTHAYA,  
KENYA**

**A thesis submitted in partial fulfillment for the degree of  
Master of Science in Construction Engineering and Management  
in the Jomo Kenyatta University of Agriculture and Technology**

This paper is as a result of investigations of cracks manifested on the surface of a recently constructed Jointed Plain Concrete Pavement (JPCP), Kagere-Munyange-Njigari-Gituiga (E571) Road in Othaya sub-county, Nyeri County of Kenya. The road was completed in the year 2012. The pavement as designed comprises 300mm thick subgrade constructed in two layers each 150mm thick compacted to 100% MDD-AASHTO T99, 150mm cement improved gravel sub- base layer on which 185mm concrete slabs are constructed.

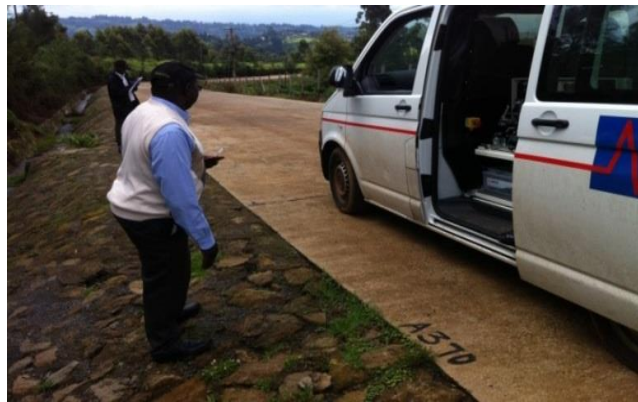
**Figure 3.3: Slab Identity marking**

The pavement was made of concrete pavement slabs demarcated by saw-cut joints in the transverse direction, and a construction joint in the longitudinal direction which also marked the center line of the pavement. The slabs in the selected study area were marked for identification with indelible marks on the slabs external longitudinal edge. The slabs in the North East Lane were marked from A1 to A443 (**Figure 3.3**) and corresponding slabs on the South West Lane were marked from B1 to B443. The marks were made at intervals of approximately 5 slabs.

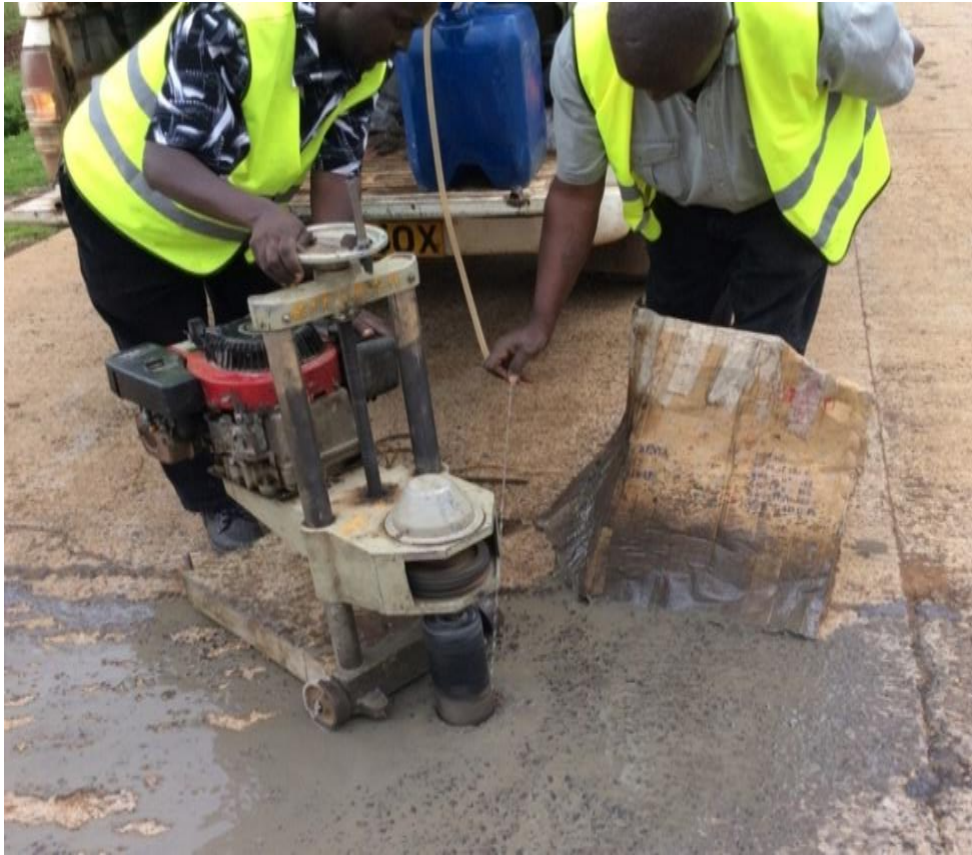
**Figure 3.4: Core cutting process on concrete slab**

The cores were cut using core cutting machine (**Figure 3.4**). The core cutter comprise a cylinder of 100mm internal diameter with a core cutting edge. During the cutting process the core is housed inside the cylinder and it is retrieved from the cylinder after the cutting operation is complete. The cutting cylinder is mechanically withdrawn from the slab. A slight tamping of the cylinder releases the cut concrete core from the housing. The details of the cut cores and the groove were recorded in concrete core extraction record form (**Appendix A**).

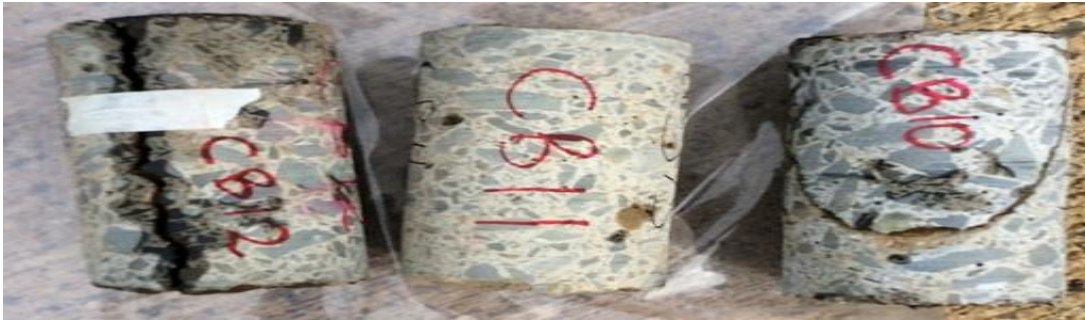
**Figure 3.5: Extracted, cleaned and marked concrete cores**

Concrete strength determination was based on solid concrete cores extracted from un-cracked concrete slabs within the research section. The concrete cores extracted were cleaned and marked with requisite core identification numbers (**Figure 3.5**).

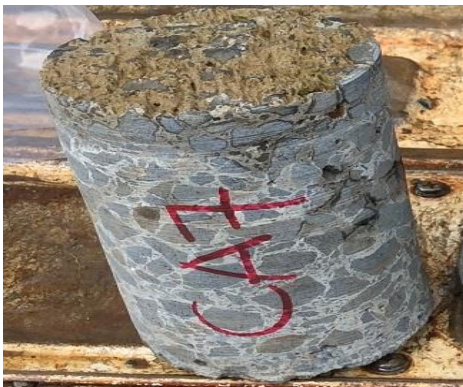
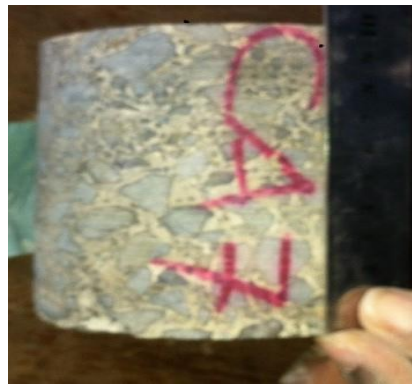
### **Figure 3.6: Sample concrete core**

The cores were trimmed lengthwise using a cutting machine to produce uniform length and flat faces suitable for compressive testing (**Figure 3.6**).

Core CA7 after extraction

Core CA7 after Trimming to size

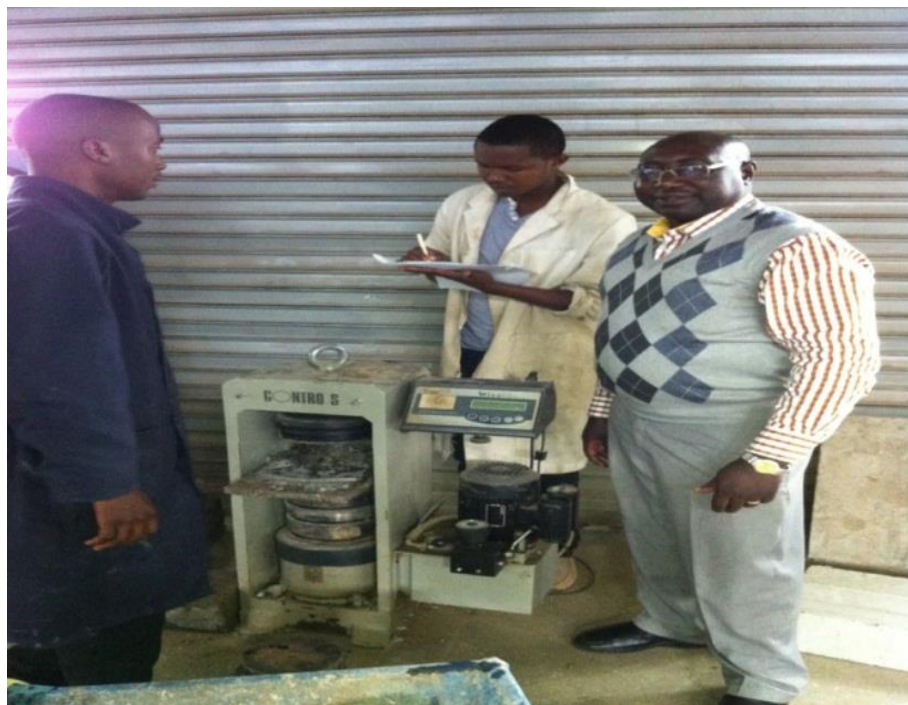
**Figure 3.7: Crushing concrete Cores.**

The machine crushing load applied was recorded and converted to cube crushing strength in  $\text{N/mm}^2$ . Three crushed core samples were randomly selected and put into sample bags for further testing to establish constituent material proportions of concrete through chemical testing.

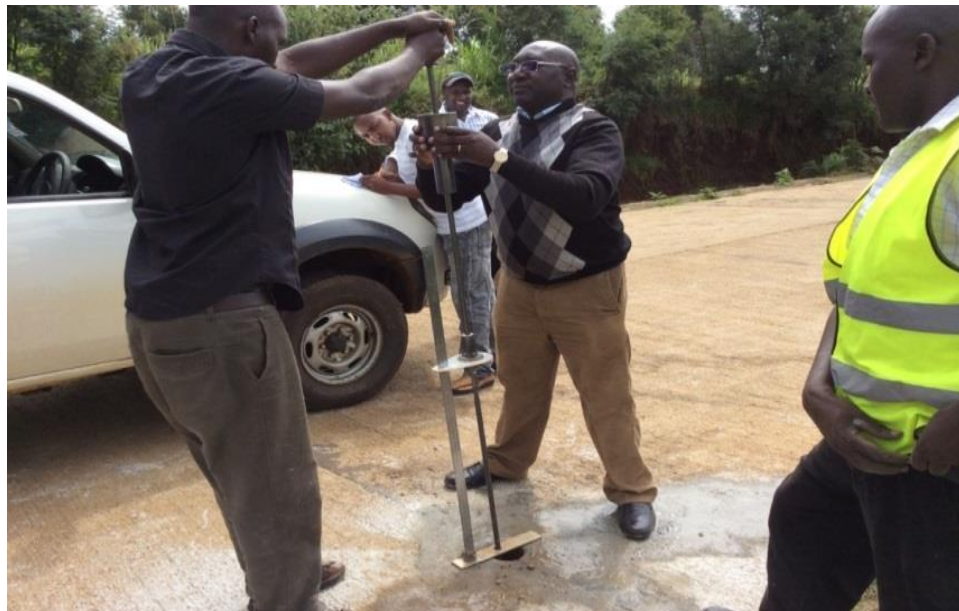
**Figure 3.10: Field testing using DCP equipment**

The cone was extracted through gentle vertical blows to the handle. For successive tests the cone was examined to ensure that it was still in good state.

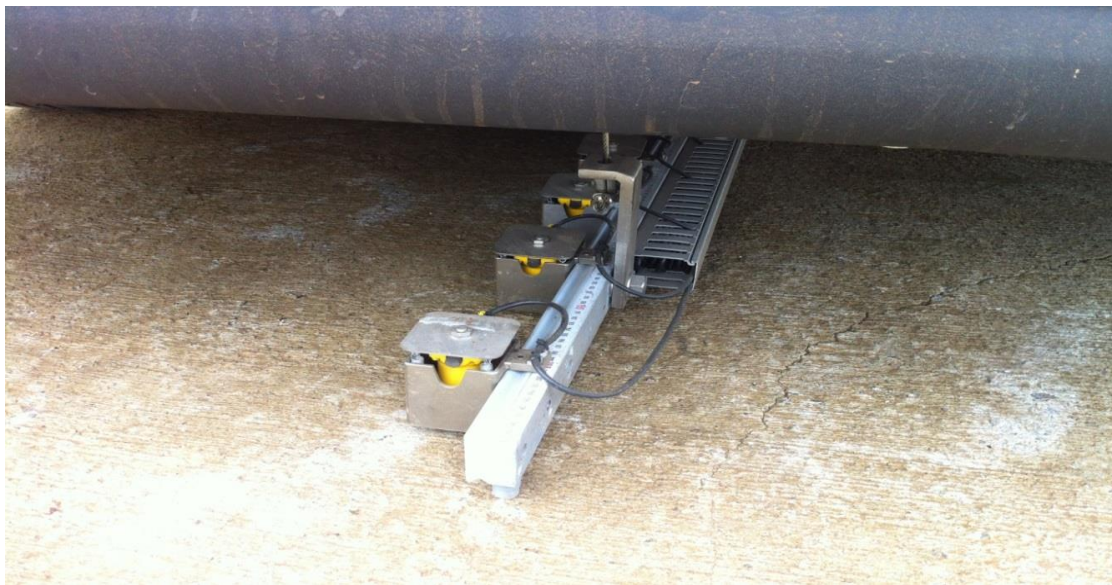
### Figure 3.11: Geophone probe sensors on pavement surface

FWD entailed dropping a standard load from a standard height. The dropped weight is matched to a typical wheel load standardized to 50 KN for FWD survey purposes. The load and loading mechanisms simulates the loading and loading time similar to that of a moving vehicle. Deflection measurements were taken from the loading point ( $d_0$ ) and at standard distances from  $d_0$  point using geophone probe sensors resting on the road surface and directly attached to loading plate (**Figure 3.11**).

The geophones which span a distance from the loading points on a geophone frame enable a “deflection bowl” to be developed thus making it possible to evaluate a particular pavement structure for layer stiffness.

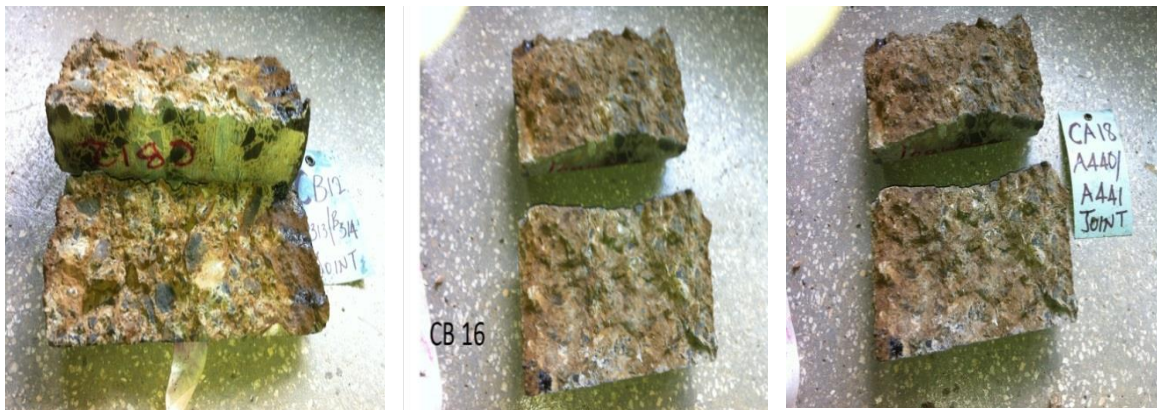
**Figure 4.1: Full cracks development under saw-cut joints**

- (i) A proportion of 37.5% of the cut joints induced full depth cracks at the cut grooves as intended (**Figure 4.1**).

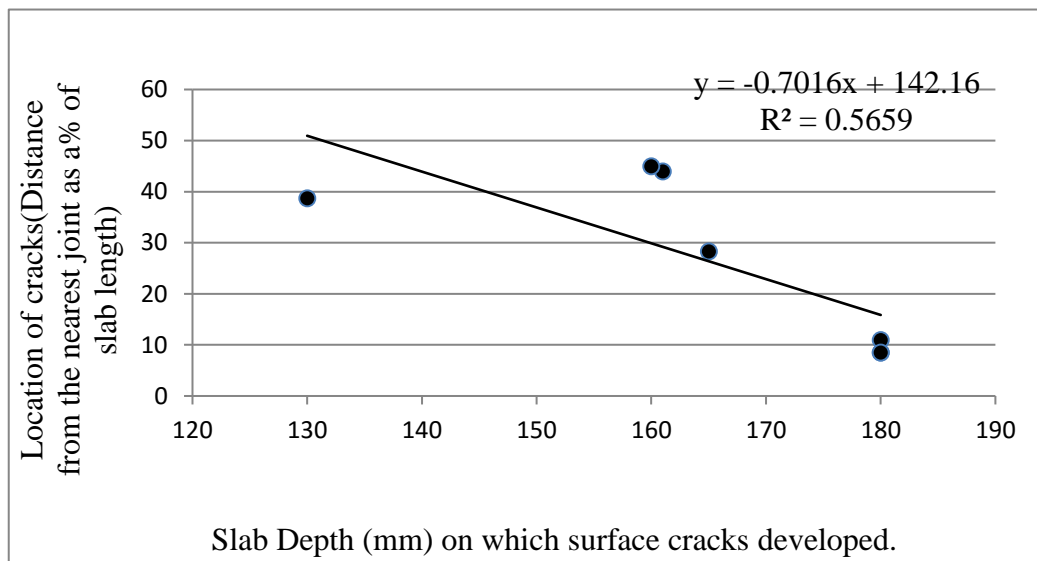
**Figure 4.3: Slab thickness and location of surface cracks**

(iii) Surface cracks developed on thicker concrete slabs nearer to the cut joints than for otherwise thinner slabs (**Figure 4.3**). The cut groove at the intended joint which unfortunately did not induce full depth crack could have weakened the slab at the point of the cut groove and hence the cracks could have concentrated at the weaker location of the thicker slabs. The shallow saw-cut joints were not effective in the induction of full depth crack and hence did not seem to have any significant influence on the location where the surface cracks on the slabs occurred (**Figure 4.4**).

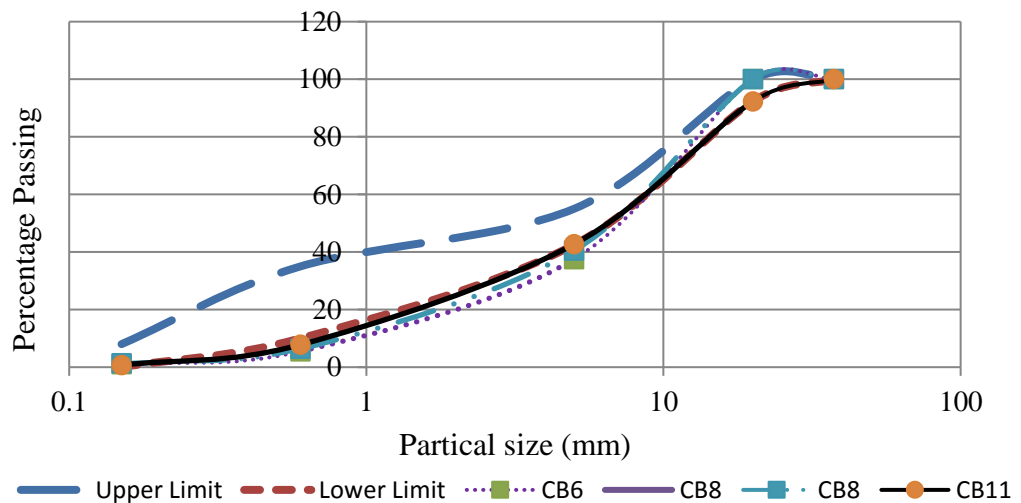
**Figure 4.6: Grading curves of aggregates.**

Aggregates that were chemically extracted from concrete cores did not meet the grading specifications. The grading curves fell below or on the lower limit curve indicating the aggregates were more course than required (**Figure 4.6**). The aggregates used therefore did not comply with aggregates grading requirements for concrete manufacture. Misappropriation of design mix proportions and apparent non-conformity to size specifications of aggregates could have been contributory to low insitu concrete slabs strength.

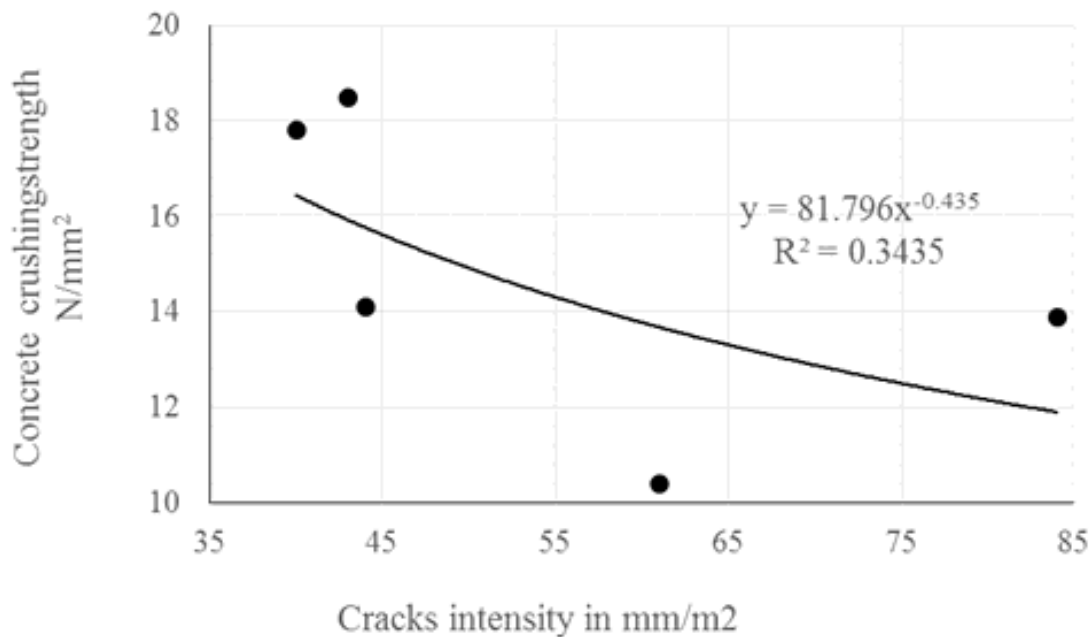
**Figure 4.7: Concrete strength and intensity of cracks.**

Evaluation of concrete strength and the intensity of the cracks on the surface of the concrete slabs showed that cracks intensity was inversely proportional to concrete strength (**Figure 4.7**).

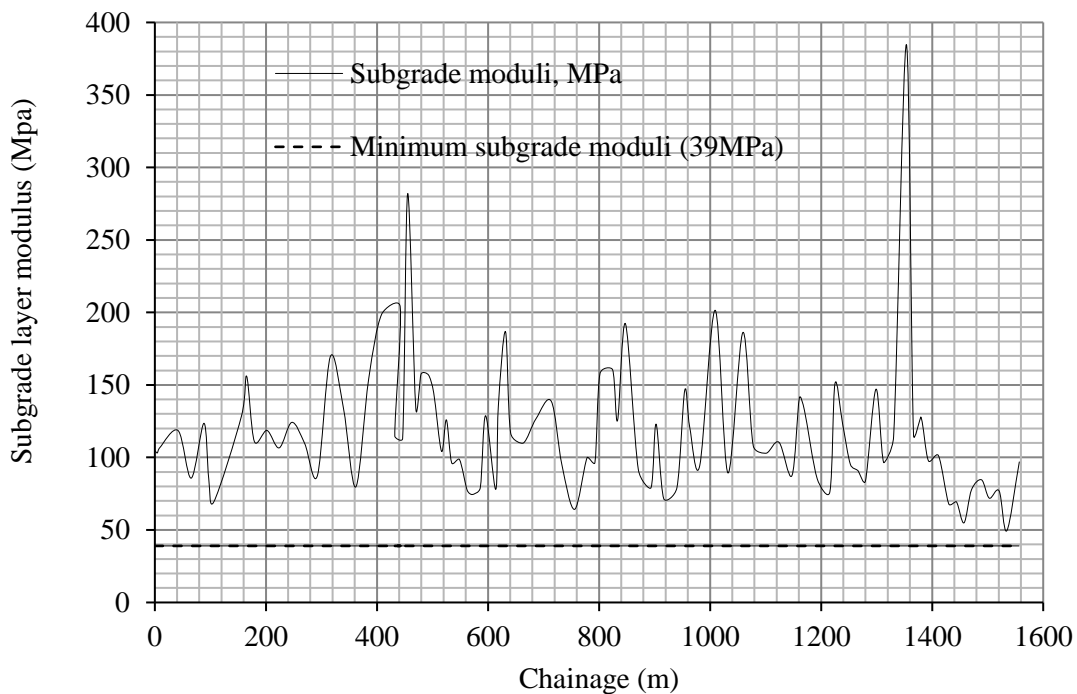
**Figure 4.8: Variation of subgrade layer modulus along the research pavement section**

Sections of subbase layer with low CBR and low layer modulus values imply sections of soft layer formation which could have been as a result of poor workmanship, application of low quality material or there could be pockets of material with high water content.

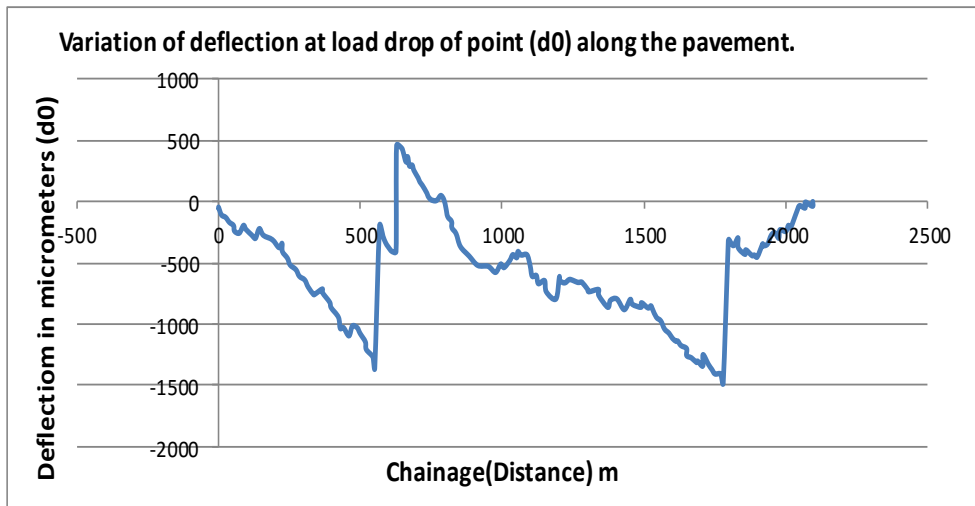
**Figure 4.10a: Variation of pavement strength characteristics along the experimental road.**

would result to reduction of individual layer strength hence undermining the support to the concrete slabs thus and consequently inducing wider and more intensive cracks on JPCP on continuous application of load. It is therefore prudent to seal the cracks at the earliest opportunity when they develop.

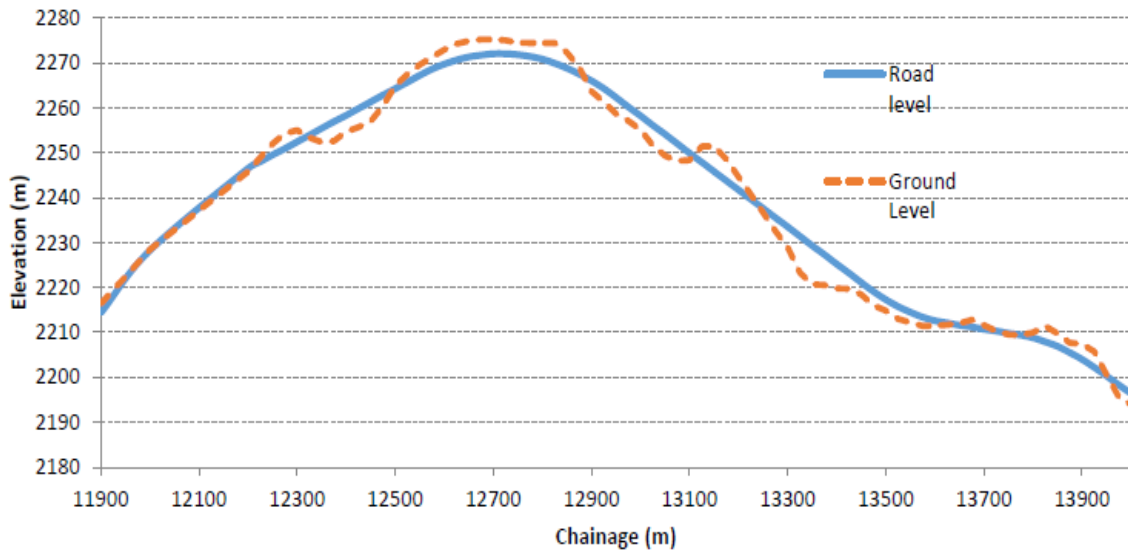
**Figure 4.17: Vertical alignment of the Jointed Plain Concrete Pavement**

Assessment of vertical road alignment of the study section (**Figure 4.17, Table 4.6**) indicates that the alignment varies from negative to positive slopes on either lane and thus the lanes are well balanced in terms of vertical alignment variations. A study of the intensity of cracks on slabs in relation to alignment slopes indicated that the intensity of cracks reduced with increased vertical gradient (**Figure 4.18**). History of construction indicate that the NE lane was constructed first followed by the SW lane. It is considered that in the process of construction of the NE lane, the contractor and the supervision team went through a learning process and had acquired adequate skills in construction process of concrete pavement during the SW lane construction and hence the reduced crack intensity.

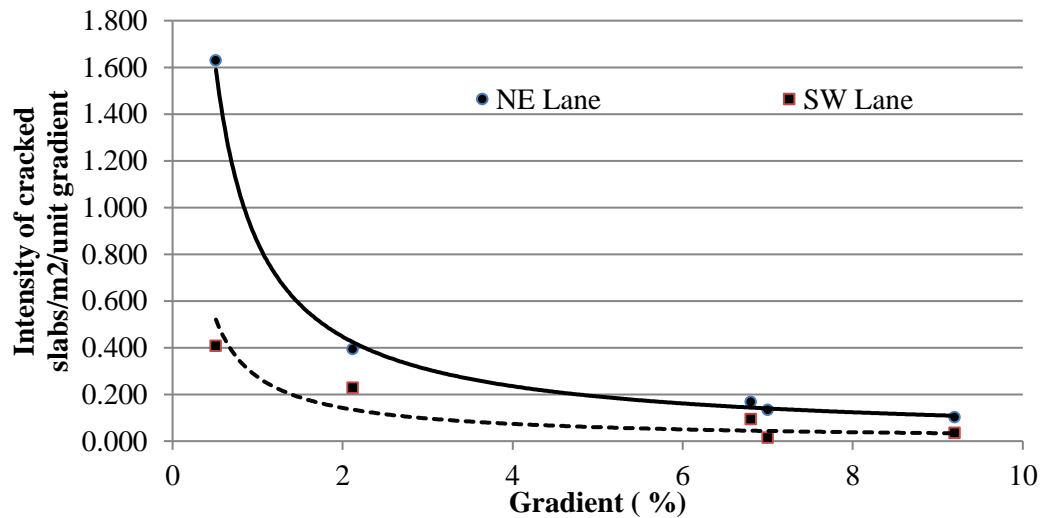
**Figure 4.18: Variation of intensity of surface cracks with vertical gradient on NE & SW Lanes**

The firmness of the insitu ground and the good drainage therefore could have provided a firm and well drained road foundation resulting to a stiff pavement thus reducing the development of surface cracks. The made up fills could have undergone differential settlement over time thus influencing occurrence of surface cracks on concrete pavement slabs.
