**CRACKING OF JOINTED PLAIN CONCRETE  
PAVEMENT: A CASE STUDY OF KAGERE- NDUNYU-  
MUNYANGE- GITUIGA (E571) ROAD IN OTHAYA,  
KENYA**

**A thesis submitted in partial fulfillment for the degree of  
Master of Science in Construction Engineering and Management  
in the Jomo Kenyatta University of Agriculture and Technology**

This paper is as a result of investigations of cracks manifested on the surface of a recently constructed Jointed Plain Concrete Pavement (JPCP), Kagere-Munyange-Njigari-Gituiga (E571) Road in Othaya sub-county, Nyeri County of Kenya. The road was completed in the year 2012. The pavement as designed comprises 300mm thick subgrade constructed in two layers each 150mm thick compacted to 100% MDD-AASHTO T99, 150mm cement improved gravel sub- base layer on which 185mm concrete slabs are constructed.

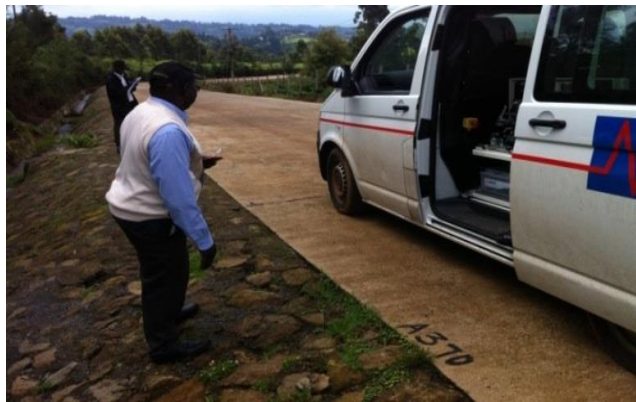
**Figure 3.3: Slab Identity marking**

The pavement was made of concrete pavement slabs demarcated by saw-cut joints in the transverse direction, and a construction joint in the longitudinal direction which also marked the center line of the pavement. The slabs in the selected study area were marked for identification with indelible marks on the slabs external longitudinal edge. The slabs in the North East Lane were marked from A1 to A443 (**Figure 3.3**) and corresponding slabs on the South West Lane were marked from B1 to B443. The marks were made at intervals of approximately 5 slabs.

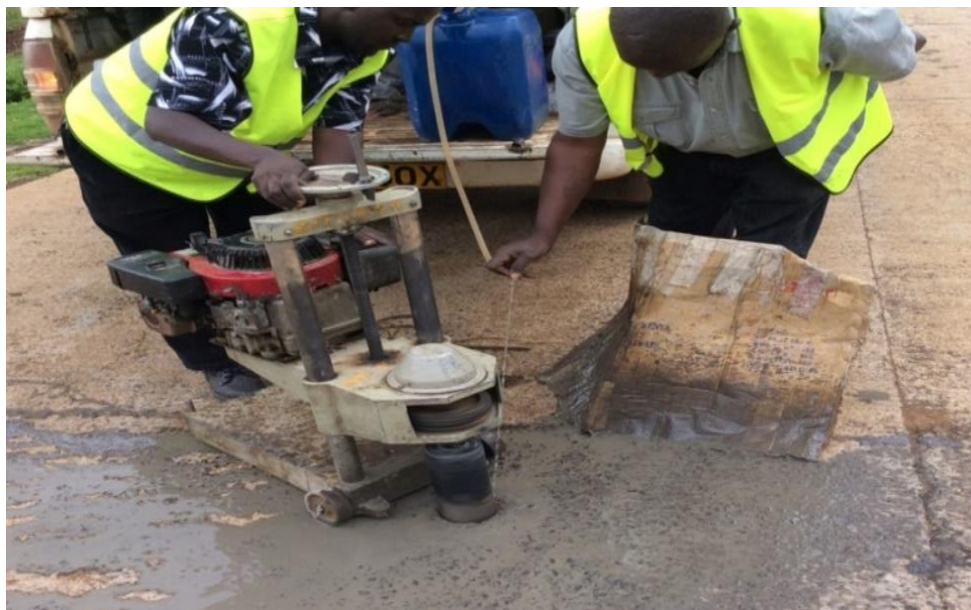
**Figure 3.4: Core cutting process on concrete slab**

The cores were cut using core cutting machine (**Figure 3.4**). The core cutter comprise a cylinder of 100mm internal diameter with a core cutting edge. During the cutting process the core is housed inside the cylinder and it is retrieved from the cylinder after the cutting operation is complete. The cutting cylinder is mechanically withdrawn from the slab. A slight tamping of the cylinder releases the cut concrete core from the housing.

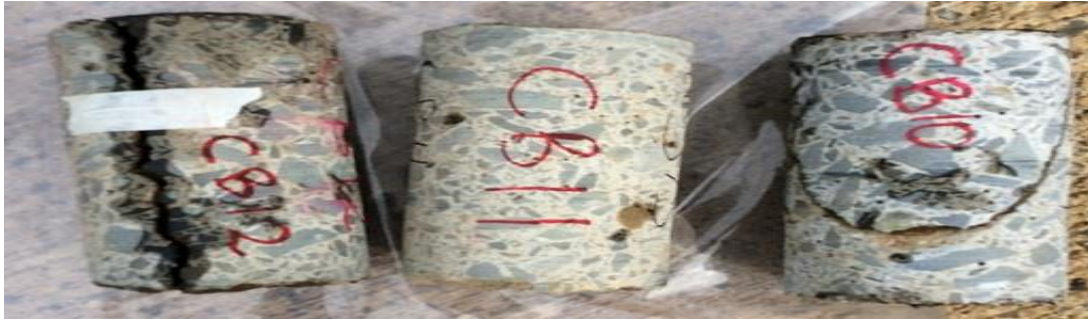
**Figure 3.5: Extracted, cleaned and marked concrete cores**

Concrete strength determination was based on solid concrete cores extracted from un-cracked concrete slabs within the research section. The concrete cores extracted were cleaned and marked with requisite core identification numbers (**Figure 3.5**).

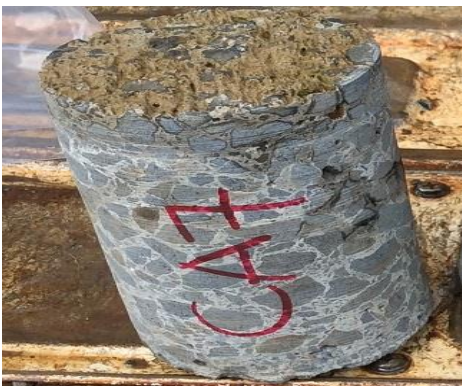
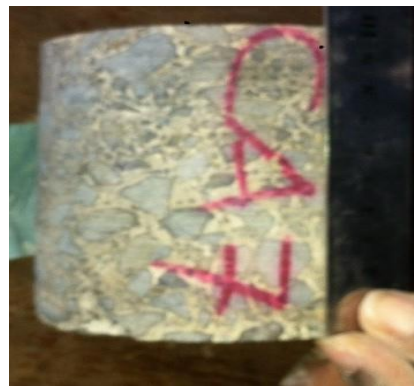
**Figure 3.6: Sample concrete core**

The cores were trimmed lengthwise using a cutting machine to produce uniform length and flat faces suitable for compressive testing (**Figure 3.6**).

Core CA7 after extraction

Core CA7 after Trimming to size

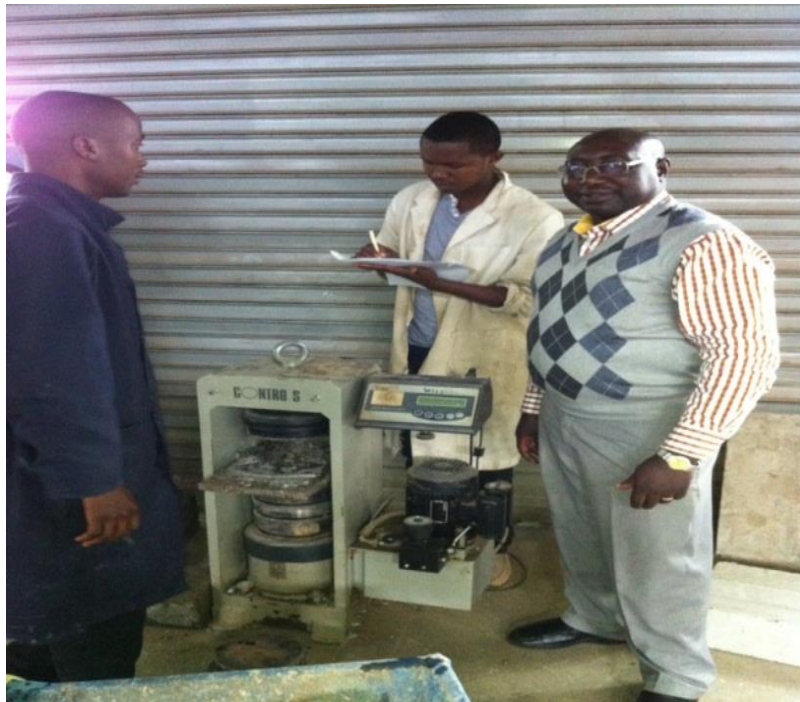
**Figure 3.7: Crushing concrete Cores.**

From the test cube strength results, concrete strength achieved from core samples were compared against designed/ expected strength. The quality of concrete making the concrete slabs in terms of concrete strength was hence determined by studying the obtained strength results.

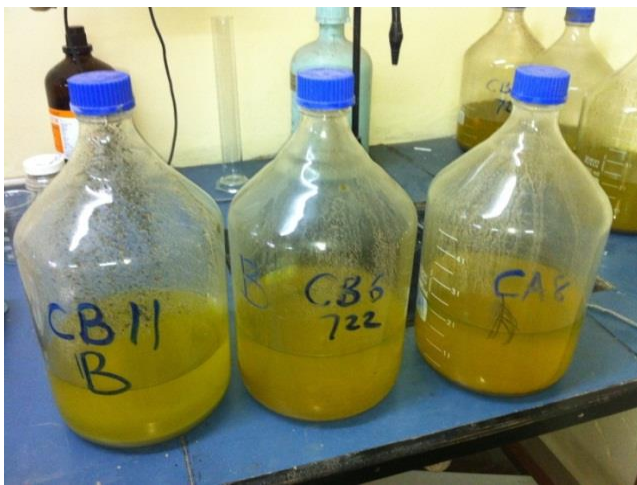
**Figure 3.8: Solution used to determine the amount of cement in concrete**

The assumption made is that the cement contained 63% of Calcium Oxide which is the case for class 42.5 N/mm<sup>2</sup> cement or OPC cement. According to site records, OPC cement was used. The solid residue was then sieved to separate coarse aggregates and fine aggregates (sand) depending on limiting sizes (**Figure 3.9**). According to the testing laboratory (MoT&I), past experiments had shown that in chemical analysis, 3% and 7% of aggregates and sand respectively are lost in the process of testing. Consequently the obtained weight of aggregates and sand were corrected by multiplying by factors of 100/97 and 100/93 respectively. Having obtained the quantity of cement, sand and aggregates in terms of weight, the ratios of cement: sand: aggregates were computed.

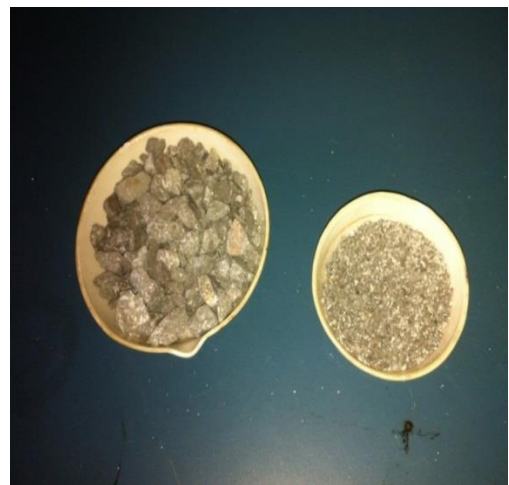
**Figure 3.9: Coarse and fine aggregates**

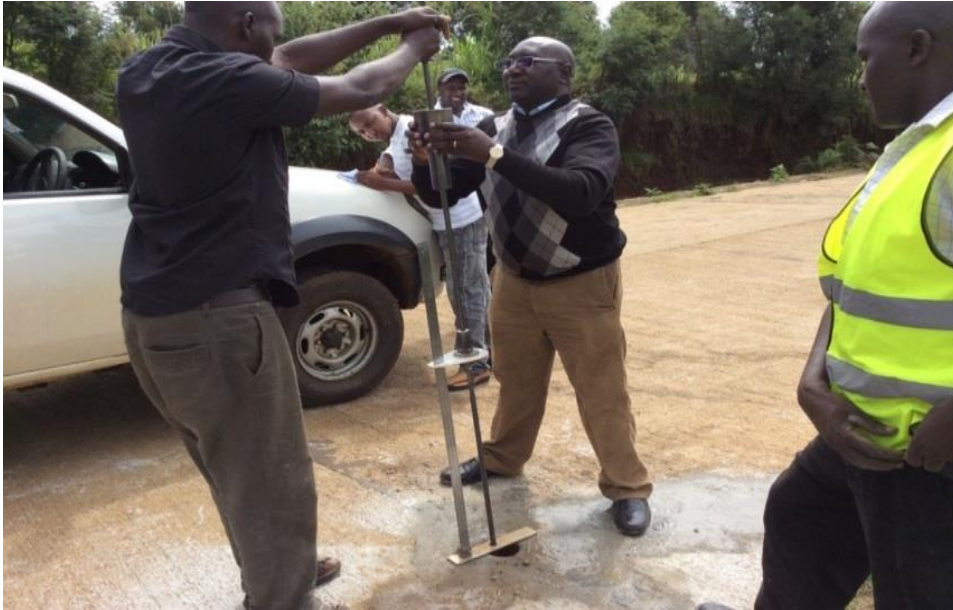
**Figure 3.10: Field testing using DCP equipment**

The cone was extracted through gentle vertical blows to the handle. For successive tests the cone was examined to ensure that it was still in good state.

DCP data collected on site was recorded in DCP test forms. The data captured the location of test which correlated to the concrete core hole, the number of blows and corresponding penetration reading on the ruler scale. The zero blow scale reading was considered as the ruler reading when the cone was at the top of the layer immediately below the concrete slab and this was the start reading. A sample test form with entries is presented in **Appendix C**.

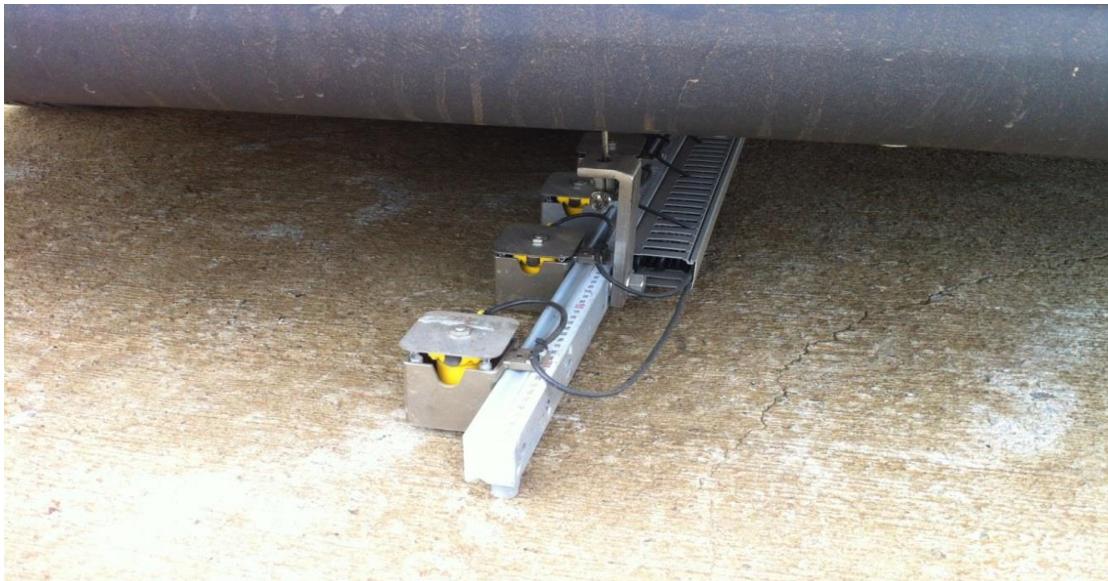
**Figure 3.11: Geophone probe sensors on pavement surface**

FWD entailed dropping a standard load from a standard height. The dropped weight is matched to a typical wheel load standardized to 50 KN for FWD survey purposes. The load and loading mechanisms simulates the loading and loading time similar to that of a moving vehicle. Deflection measurements were taken from the loading point ( $d_0$ ) and at standard distances from  $d_0$  point using geophone probe sensors resting on the road surface and directly attached to loading plate (**Figure 3.11**).

The geophones which span a distance from the loading points on a geophone frame enable a “deflection bowl” to be developed thus making it possible to evaluate a particular pavement structure for layer stiffness.

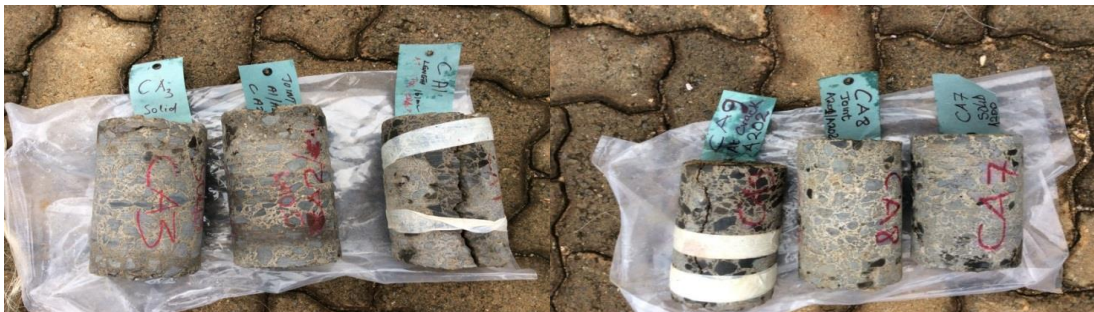
**Figure 4.2: Cracking patterns in the experimental pavement**

(ii) Cracks developed on the surface of the slabs at varying distances from the cut groove and almost always parallel to the transversely cut joints. **Figure 4.2** shows two sets of cores that were cut from slabs at varying locations from the saw-cut joints. Cracks which developed on surface of the slabs are also illustrated. The two sets had concrete cores CA1, CA2, CA3 and CA7, CA8 and CA9 respectively. Cores CA2 and CA8 were extracted from the saw-cut joints, they are solid and hence the saw-cut joints did not induce the intended cracks.

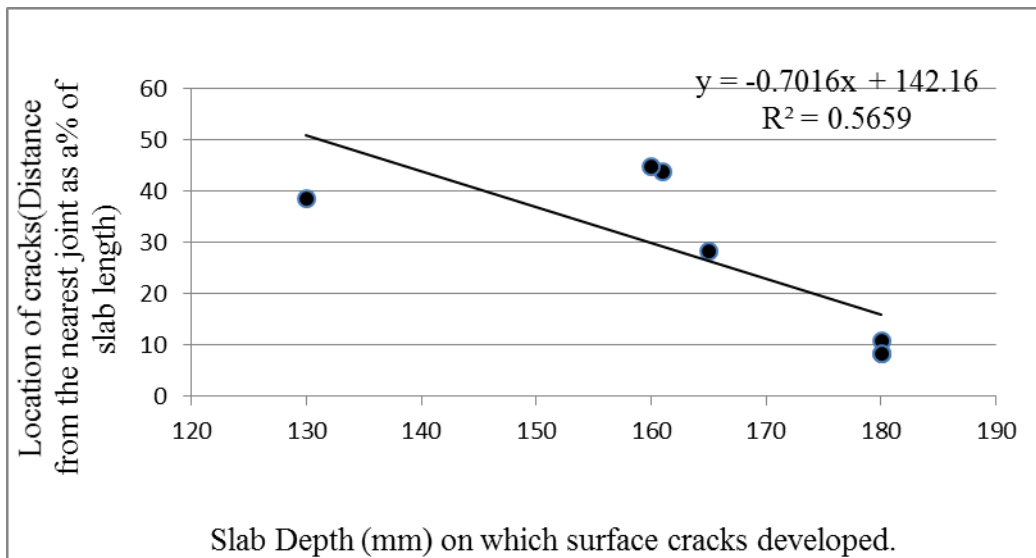
**Figure 4.3: Slab thickness and location of surface cracks**

(iii) Surface cracks developed on thicker concrete slabs nearer to the cut joints than for otherwise thinner slabs (**Figure 4.3**). The cut groove at the intended joint which unfortunately did not induce full depth crack could have weakened the slab at the point of the cut groove and hence the cracks could have concentrated at the weaker location of the thicker slabs. The shallow saw-cut joints were not effective in the induction of full depth crack and hence did not seem to have any significant influence on the location where the surface cracks on the slabs occurred (**Figure 4.4**).

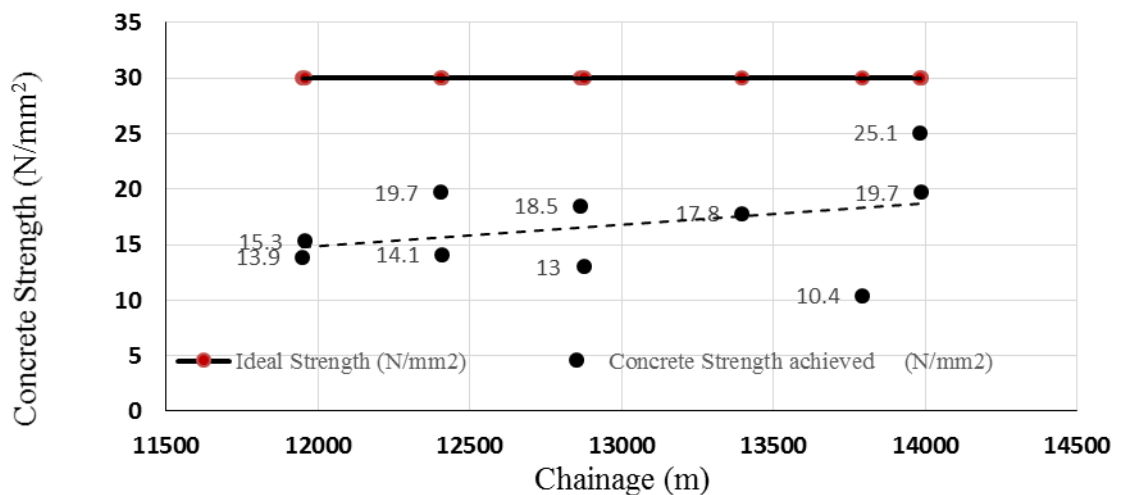
**Figure 4.5: Concrete slab crushing strength**

The crushing tests gave concrete strength values which varied substantially. None of the tested samples met the design strength threshold of 30 N/mm<sup>2</sup> (**Figure 4.5**). Forty percent (40%) of the concrete samples tested gave results of non-structural concrete (strength values below 15 N/mm<sup>2</sup>). The average concrete strength achieved was 16.75 N/mm<sup>2</sup> which is only 56% of desired concrete strength.

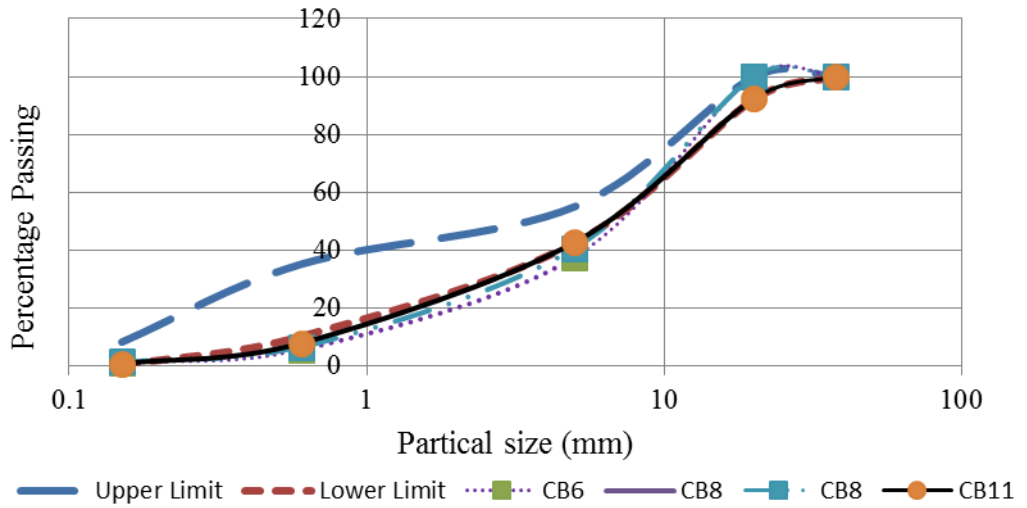
**Figure 4.6: Grading curves of aggregates.**

Aggregates that were chemically extracted from concrete cores did not meet the grading specifications. The grading curves fell below or on the lower limit curve indicating the aggregates were more coarse than required (**Figure 4.6**). The aggregates used therefore did not comply with aggregates grading requirements for concrete manufacture. Misappropriation of design mix proportions and apparent non-conformity to size specifications of aggregates could have been contributory to low insitu concrete slabs strength.

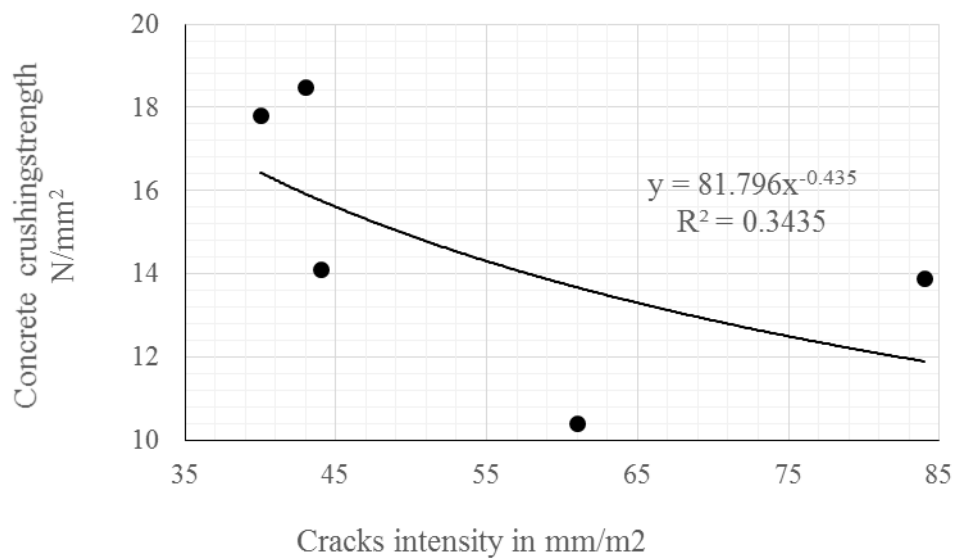
#### **Figure 4.7: Concrete strength and intensity of cracks.**

Evaluation of concrete strength and the intensity of the cracks on the surface of the concrete slabs showed that cracks intensity was inversely proportional to concrete strength (**Figure 4.7**).

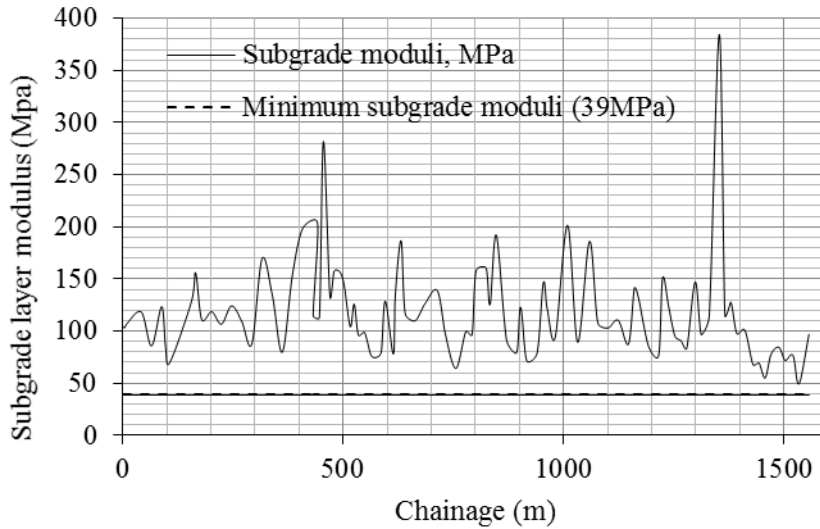
**Figure 4.8: Variation of subgrade layer modulus along the research pavement section**

Sections of subbase layer with low CBR and low layer modulus values imply sections of soft layer formation which could have been as a result of poor workmanship, application of low quality material or there could be pockets of material with high water content.

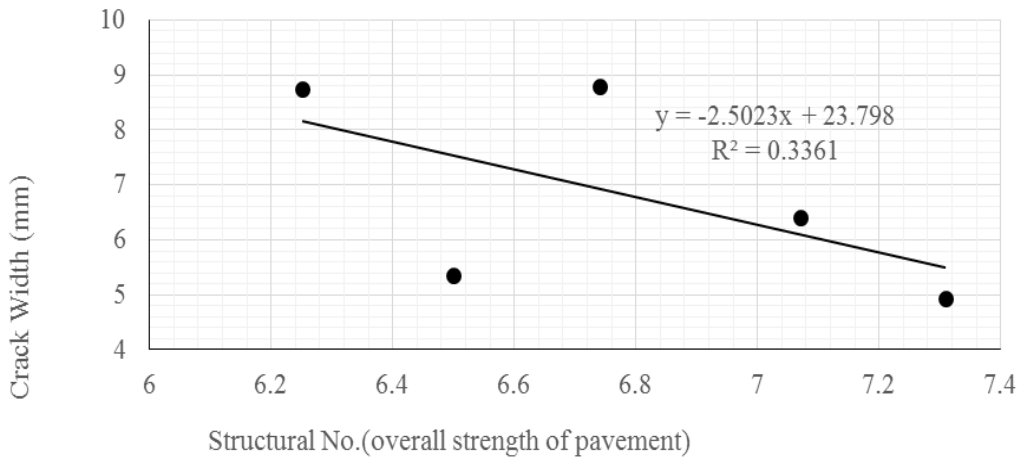
**Figure 4.11: Strength of pavement and the width of cracks**

Assessment of how the overall pavement strength related to the cracks on the surface of concrete pavement slabs was evaluated by comparing width of cracks to SNP. The assessment revealed that the width of the cracks reduced in size as the SNP (overall pavement strength) increased (**Figure 4.11**).

From the relationship it can be inferred that the stronger the pavement the smaller the width of generated cracks. The generated cracks were relatively tight and may not have an effect on long term performance of the JPCP. The strength of entire pavement is a

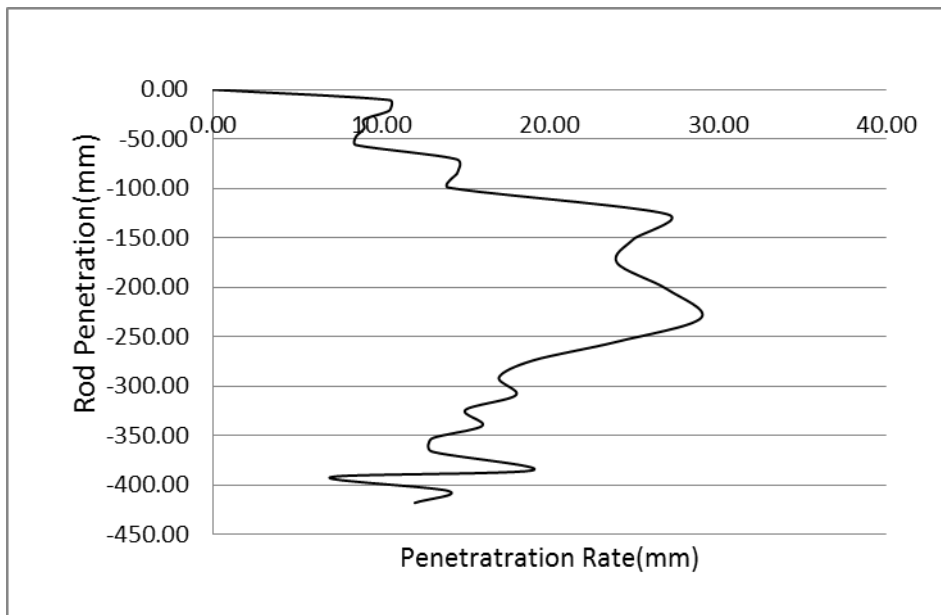
**Figure 4.12: Typical Soil profile for the study site**

sum total of individual pavement layer strength, material quality and adherence to construction standards. Variations in homogeneity of pavement layer (**Figure 4.12**) portray changes in pavement characteristics which impacts on overall quality and strength of the pavement. The width of the non-uniform surface cracks on concrete pavement were found to be small but were established to run full depth in the concrete slab (**Figure 4.2**). These cracks could pose potential danger to underlying pavement layers if water ingresses through the cracks to the subbase and subgrade layers. This would result to reduction of individual layer strength hence undermining the support to the concrete slabs thus and consequently inducing wider and more intensive cracks on JPCP on continuous application of load. It is therefore prudent to seal the cracks at the earliest opportunity when they develop.

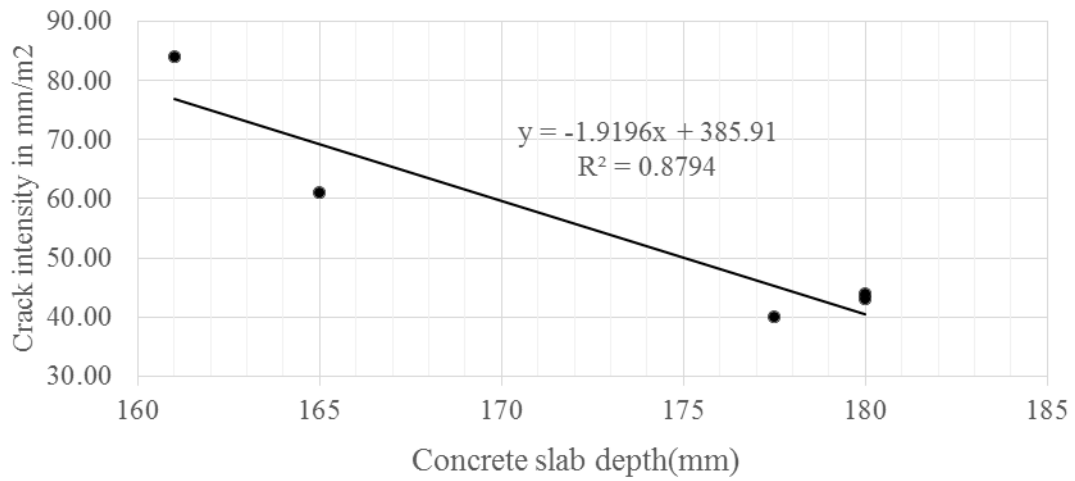
**Figure 4.15: Effect of slab thickness to crack intensity**

Thickness of concrete pavement contributes to the stiffness of the overall pavement and hence defines the strength regime of the pavement. Comparison of thickness of concrete pavement slabs measured from concrete cores to the crack intensity in locations of cores extraction indicated that surface cracks significantly reduced with increased slab thickness (**Figure 4.15**). A 20 mm increase in slab thickness reduced the cracks intensity by approximately 50%. Increasing slab thickness of JPCP increases pavement stiffness and hence reduces pavement deflection. It has further been established that crack width on the concrete pavement surface proportionately increased with pavement deflection (**Figure 4.16**). Adequate thickness of concrete slabs is a prerequisite in preventing premature development of surface cracks.

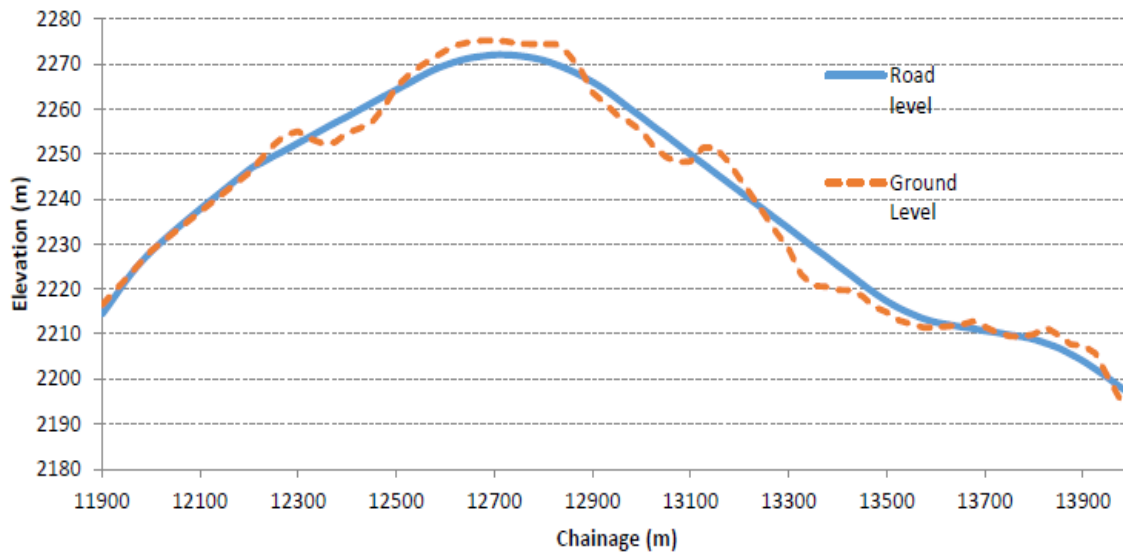
**Figure 4.17: Vertical alignment of the Jointed Plain Concrete Pavement**

Assessment of vertical road alignment of the study section (**Figure 4.17, Table 4.6**) indicates that the alignment varies from negative to positive slopes on either lane and thus the lanes are well balanced in terms of vertical alignment variations. A study of the intensity of cracks on slabs in relation to alignment slopes indicated that the intensity of cracks reduced with increased vertical gradient (**Figure 4.18**). History of construction indicate that the NE lane was constructed first followed by the SW lane. It is considered that in the process of construction of the NE lane, the contractor and the supervision team went through a learning process and had acquired adequate skills in construction process of concrete pavement during the SW lane construction and hence the reduced crack intensity.

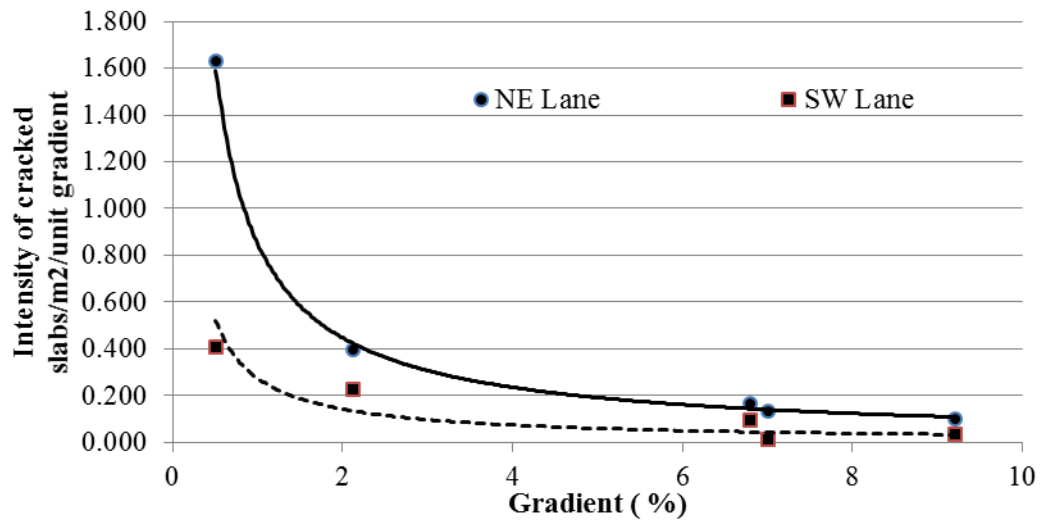
**Figure 4.18: Variation of intensity of surface cracks with vertical gradient on NE & SW Lanes**

It can therefore be concluded that topography and vertical disposition of the alignment had direct influence in the development of the cracks. In sections with high vertical gradients it is highly likely that the road was generally in cut or had limited fill and the drainage was good and therefore the pavement foundation was on compacted insitu soils with minimum fills while on lower gradients the road was mainly in compacted fills. The firmness of the insitu ground and the good drainage therefore could have provided a firm and well drained road foundation resulting to a stiff pavement thus reducing the development of surface cracks. The made up fills could have undergone differential settlement over time thus influencing occurrence of surface cracks on concrete pavement slabs.
