## EFFECT OF MUNICIPAL SOLID WASTE ASH ON THE STRENGTH OF EARTHEN BRICKS AND WALLS

### Abstract

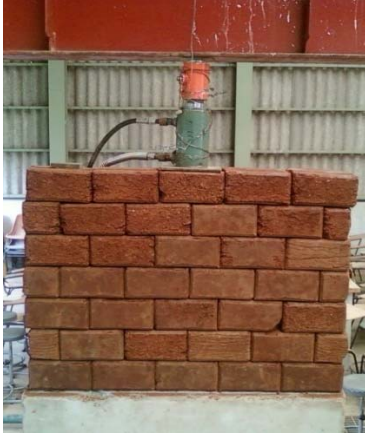
The mechanical properties of the bricks were determined in accordance with BS EN 772-1, 2003. Walls were constructed using the guidelines of design code EN 1052-1 of 1999. The wall height was 840 mm and its length was 1100 mm. In one case two walls (two replicates) were constructed using un-stabilized clay bricks and in another case two walls (two replicates) were constructed using bricks stabilized with 2% MSWA. A load was applied on the wall using a load cell (capacity of 50 metric tonne force) and a hydraulic pump (Figure 1). A transducer was used to measure the vertical deflection of the wall and a data logger was used to record the ultimate load

and the stress-strain relationship of the wall. Crack pattern on the failing wall was visually observed.

Figure 1: Typical arrangement of wall model for testing

Compressive strength of masonry walls constructed using interlocking bricks  
 As explained in the methodology, walls were constructed based on the design standard EN 1052-1 of 1999. The wall height was 840 mm and its length was 1100 mm. In one case two walls (two replicates) were constructed using un-stabilized clay bricks and in another case two walls were constructed using bricks stabilized with 2% MSWA. The stress-strain relationship of each wall was also determined. For the wall constructed using bricks stabilized with 2% MSWA the maximum compressive stress on the wall was 2.47 N/mm<sup>2</sup>, occurring at a strain of 11. On the other hand un-stabilized Juja soil masonry wall had a maximum compressive stress of 2.5 N/mm<sup>2</sup> occurring at a strain of 9.5 (Figure 8).

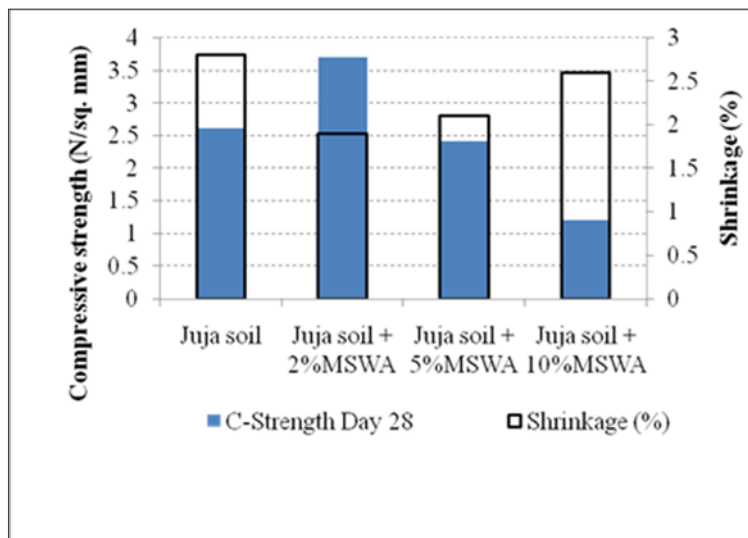
The volume of clay bricks was held constant; hence the weight of the bricks depended on the characteristics of the soil paste used to make them. Compared to bricks made from Juja soil stabilized with 2% MSWA, those made from un-stabilized soil had higher shrinkage and addition of 2% MSWA resulted in heavier bricks (Table 2). The average compressive strength of interlocking bricks from Juja soil stabilized with 2% MSWA was 3.696 N/mm<sup>2</sup> with low variations (Table 2). The addition of more than 2% MSWA reduced the compressive strength of the bricks, but increased brick shrinkage (Figure 3).

Figure 3: The effect of MSWA on the compressive strength and shrinkage of soil bricks

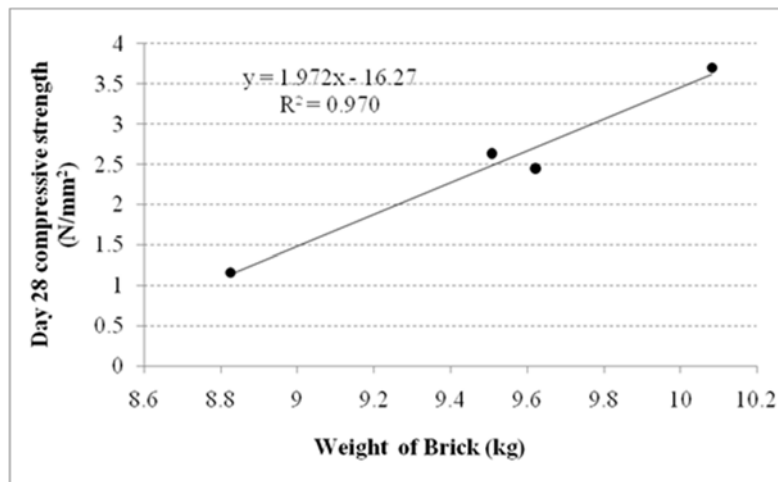
The compressive strength of clay bricks linearly increased with increasing brick weight (Figure 4). However, shrinkage decreased with increasing brick weight

Figure 4: Variation of brick compressive strength with brick weight

(Figure 5). Since a dense brick has fewer voids, it is expected that the shrinkage would reduce with increase in brick weight. Soil stabilization causes bonding of soil particles and therefore results in a more densely packed mass of soil. From these results, it appears that brick weight can be used as an indication of the compressive strength of the brick.

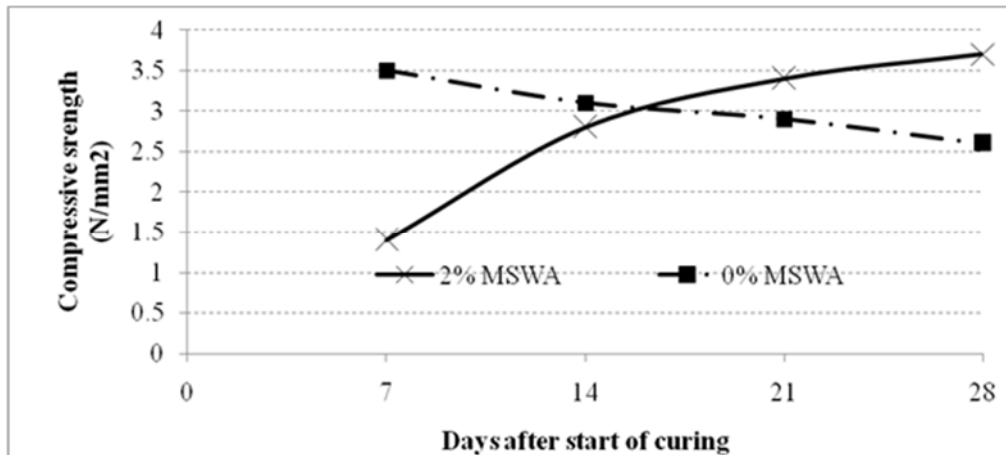
This study established that during the curing period the bricks gained strength (Figures 6 and 7). This phenomenon was clearest in the case of addition of 2%

MSWA. When more than 2% MSWA was added, this caused the curing effect not to be obvious, and the compressive strength did not seem to change significantly after day 7. This further confirms earlier observation that there exists an optimum amount of pozzolanic material beyond which gain in compressive strength, during the curing period, ceases. Stabilization of Juja soil with 2% MSWA reduced shrinkage by 32% and increased compressive strength by 42%.

Figure 6: Variation of the compressive strength of clay bricks during the curing period.

After 7 days of curing, un-stabilized Juja soil bricks were strongest, with a compressive strength of 3.5 N/mm<sup>2</sup>. However, the strength of un-stabilized bricks reduced with age to a final compressive strength of 2.5 N/mm<sup>2</sup> (Figure 6). According to Okunade (2008) early compressive strength of clay soils is associated with the bonding of clay minerals. However, this strength is not sustained over a long period of time due to weakening of the bonds. Therefore the early strength of un-stabilized Juja soil bricks can be associated with hardening of the soil encouraged by fusion of the clay minerals. Addition of an optimum amount of municipal solid waste ash, in this case 2% MSWA, resulted in a sustained increase in compressive strength during the curing period (Figure 7).

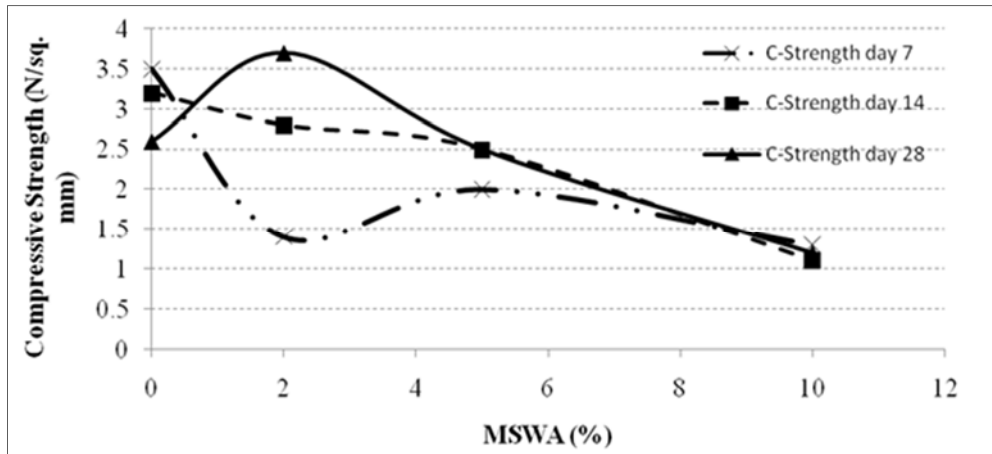
Figure 7: Variation of the compressive strength of clay bricks with the content of stabilizer

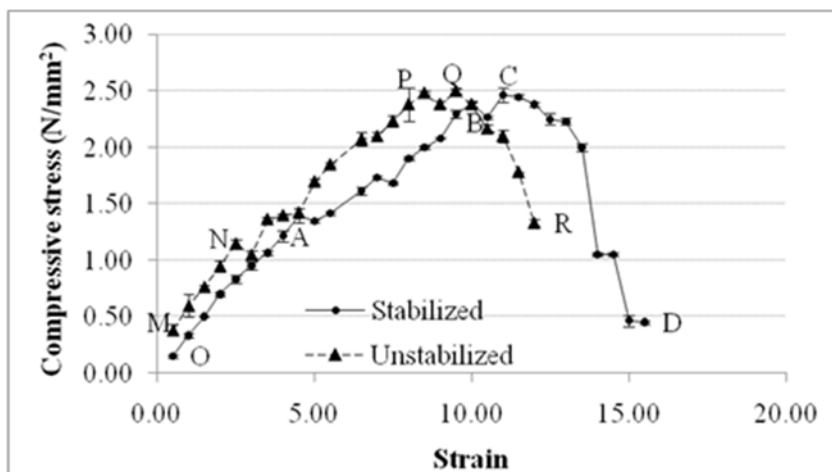
Figure 8: Stress-strain behaviour of 2% MSWA stabilized and un-stabilized soil walls

The stress-strain curve for un-stabilized and stabilized Juja soil wall had three stages (Figure 8). The ascending part of the curve for 2% MSWA stabilized Juja soil masonry wall was found to behave linearly (section OA) up to about half of the ultimate stress. The first crack was observed at point A, where there was a slight fall of stress value. The cracks began to increase in length, width and number, as the stress increased beyond point A. The wall reached its ultimate stress at point C. Although the wall did not completely collapse, it experienced excessive cracking and bulging at the wall sides and could not support more stress. Point D indicates the total collapse of the wall.

The unstabilized Juja soil masonry wall had its first crack point (point N) occurring at a stress value of 1.15 N/mm<sup>2</sup> and a strain of 2.5. This crack occurred at a lower stress than that of the first crack of the stabilized Juja soil wall (1.43 N/mm<sup>2</sup>). In this study, there was a delayed development of cracks in stabilized Juja soil wall as compared to the un-stabilized wall. This shows that, the presence of MSWA as a stabilizer increases the ductility of the wall. After attaining the ultimate stress, the stabilized Juja soil wall could not collapse easily as compared to the un-stabilized wall. This was indicated by a short-sharp fall (QR) of the curve for the un-stabilized Juja soil wall. Studies by McNary and Abrams (1985) indicated that the ductility of a wall was negatively affected by the use of strong mortar. Their study showed that wall ductility depends on the strength characteristics of individual bricks. This has been confirmed by the current study.

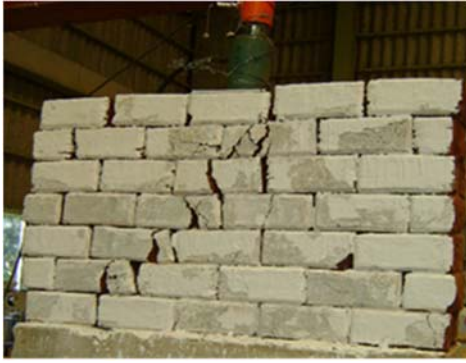
The failure mode of the walls was investigated in terms of cracks formation and the vertical deflection. For the 2% MSWA stabilized Juja soil wall, the cracks started directly below the top steel plate (Figure 9a). The cracks propagated diagonally with minor vertical splitting cracks also occurring. Since there was no mortar, the cracks were caused by secondary tensile stresses resulting from the restrained deformation of the frogs in the bed joints of the brick-work. This kind of failure is similar to the normal mode of failure reported by Berto *et al* (2005) for masonry constructed using weaker mortar. The maximum crack width at failure was 40 mm wide while the vertical deflection of the wall was 20 mm (Table 3).

Figure 9: (a) Failure of 2% MSWA

- viii. While the un-stabilized walls had nearly vertical cracks, the failure of 2% MSWA stabilized soil brick wall was ductile and its cracks propagated diagonally at an angle of 45° from the point of load application. This type of failure was consistent with the provision of the design code BS 5628 Part 1 of the year 2005. Therefore, this design code can also be used in the design of MSWA stabilized brick walls.

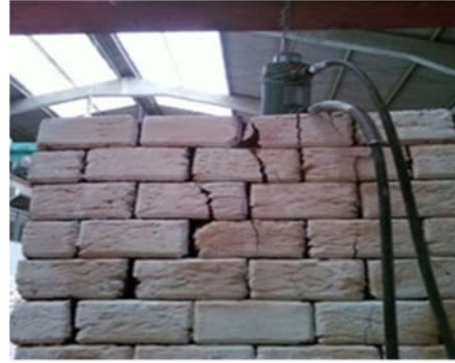
(b) Failure of un-stabilized brick wall  
stabilized brick wall

The failure of un-stabilized Juja soil masonry wall was initiated by vertical cracks directly below the load application point (Figure 9b). The cracks propagated vertically below the wall face. When the ultimate stress was reached, the wall bulged from the edges and created disjoints in the interlocking bricks. This could have been due to high stiffness of the un-stabilized bricks that tend to reduce the lateral strains in the wall leading to a state of tri-axial compression in the wall. Vertical splitting of the wall can be attributed to the phenomenon of shear failure which can be found in compression of brittle materials (Vonk, 1992). This failure mode indicated that the un-stabilized Juja soil bricks are brittle and when utilised in masonry, their crack development is faster than for Juja soil bricks stabilized the MSWA.
