## THERMAL STRESS MEASUREMENT ON PISTON RINGS BY REAL TIME HOLOGRAPHIC INTERFEROMETRY

### Abstract

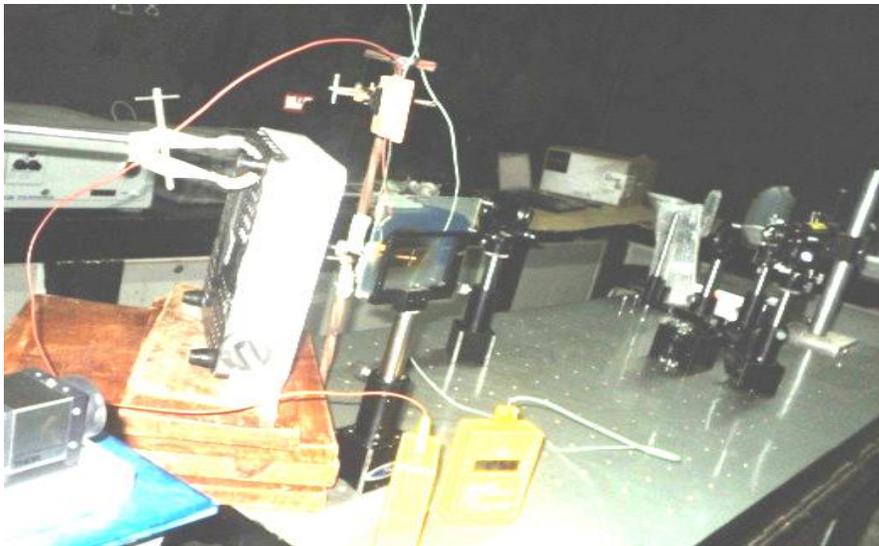
*Figure 1: Real time holographic interferometric set-up. The developed plate was replaced on the holder and the object subjected to heating. Using the CCD camera the generated interferograms were captured for analysis*

To measure the effect of thermal stress on the piston rings, three new motor cycle piston rings of the same piston were used. The set-up used to measure the thermal stress on the piston rings is as shown in Figure 1. The process was carried out in two major steps. First the piston ring hologram was recorded on

The dry chemically processed holographic plate was inserted on the holographic plate holder and illuminated with the reference beam only as the object beam was blocked with a shutter. The holographic image observed was captured by use of a digital camera. Later the processed holographic plate and the piston ring were illuminated by reference beam and object beam respectively. This process led to generation of interferograms which were captured by a CCD camera of pixel resolution 1024x768 and used as the reference interferogram. To measure the temperature changes, two thermo couples were used placed equidistant from each other to ensure uniform temperature distribution. On heating the piston ring as the developed holographic plate was illuminated by reference and the ring illuminated by object beams in the same orientation as during hologram recording, interferograms were generated. These interferograms were as a result of the interference between the reconstructed object beam and the new object beam carrying information of thermal stress on the ring. The generated interferograms were captured for analysis at temperature intervals of 50C until a temperature of 1000C was attained. To determine the effect of thermal stress on the piston rings both qualitative and quantitative analysis was carried out. The quantitative analysis of the interferograms was done using Atmosfringe version 3.3 software and origin version 8 software.

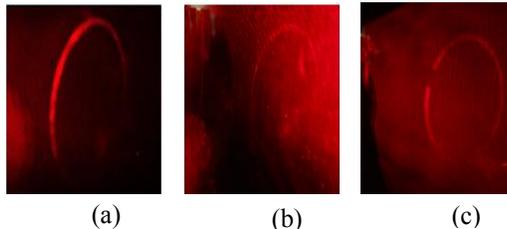
Figure 2: Photographic images of: (a) A hologram of piston ring 1. (b) A hologram of piston ring 2. (c) A hologram of piston ring 3

To access the information encoded on the holographic plate on exposure, the development of the exposed plate was carried out. After processing of the exposed plate, it was inserted on the holographic plate holder and replayed. This was done by illuminating the processed holographic plate using reference beam. The reconstruction process affirmed the presence of successfully recorded hologram of the piston ring under test. To capture the holographic images of the piston ring a 16.2 Megapixels Kodak digital camera was used. The photographs of the hologram images are as shown in Figure 2(a), (b) and (c).

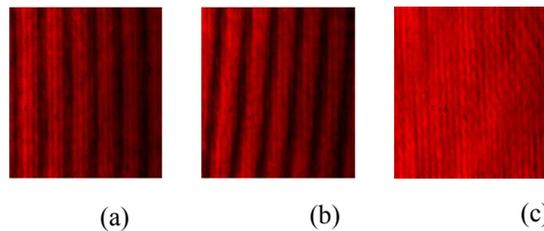
Figure 3: Sample interferograms captured by CCD for piston ring 2. The interferograms were characterized by geometrical variation as temperature increased. (a) The interference fringes are linear at 25°C (b) The interference fringes are curved at 35°C (c) The interference fringes appear compressed at 100°C

As piston ring 2 was subjected to thermal stress, a unique behavior of interferograms was observed. It was noticed that at low thermal stress (temperatures) the interference fringes were linear but from temperature increased the interferograms were characterized by geometrical variation in reference to interferograms recorded before the piston ring was subjected to thermal stress. This variation were more visible to the sense of sight at temperatures of 25°C, 35°C and 100°C as shown in figure 3(a), (b) and (c).

These were characterized by bending and compression of the interferograms. The compression of the interference fringes was depicted by an increase in optical fringe densities where more fringes occupy a unit length than before. This also affected visibility of the interferograms without the aid of a CCD camera due to resolution limitation of the human eyes.

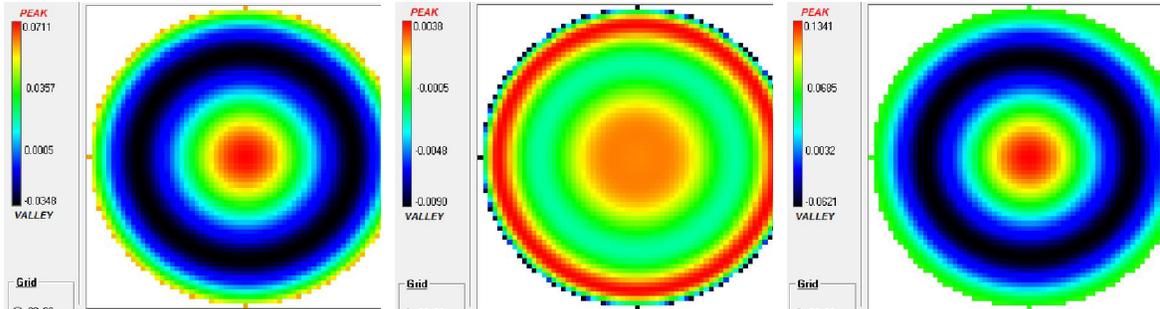
Figure 4 (i): Graphical analysis of wavefront surface of piston rings at 25°C. The profiles illustrate the P-V aberration of the piston rings as they were subjected to thermal stress. The P-V aberration for (a) ring 1 is 67.0 nm (b) ring 2 is 8.1 nm and (c) ring 3 is 124.2 nm

was obtained. The analysis revealed a variation of aberrations with change in temperature for each of the piston ring under test. 2D graphical analysis of the inteferograms obtained for sampled temperature of 25°C, 40°C and 60°C on the piston rings are displayed in the figures 4(i), (ii) and (iii).

The analysis clearly displays in Figures 4. of variation in peaks and valleys of the interferogram as temperature varied. The variations were characterised by shifts in peak and valleys of the interferograms for the same piston ring as thermal stress was increased for example at temperature of 25°C, 40°C and 60°C piston ring 1 had P-V aberrations of 67.0nm, 214.9nm and 69.7nm respectively. The same trend was

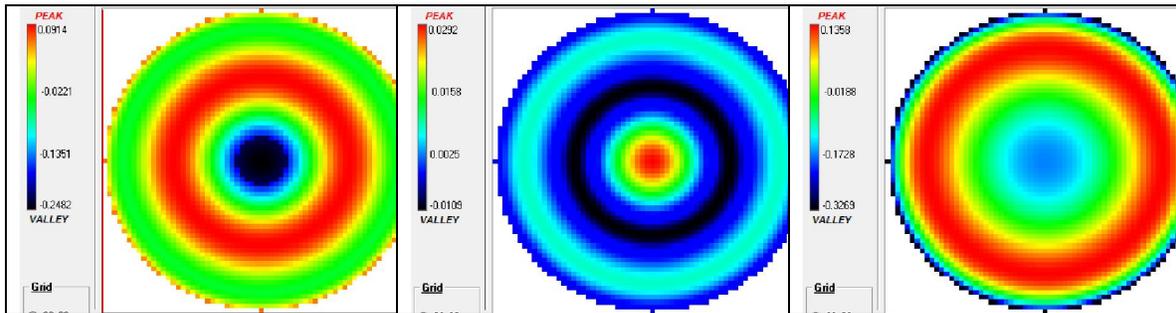
Figure 4 (ii): Graphical analysis of wavefront surface of piston rings at 40°C. The profiles illustrate the P-V aberration of the piston rings as they were subjected to thermal stress. The P-V aberration for (a) ring 1 is 214.9 nm (b) ring 2 is 825.4 nm and (c) ring 3 is 292.8 nm

observed from the other two rings that were under investigation. Similarly at the same temperature the piston rings interferograms had different P-V aberrations. For example at 40°C, ring 1, 2 and 3 had P-V aberrations of 214.9nm, 25.4nm and 292.8nm respectively. The variations in aberration between piston rings at the same temperature demonstrated their structural differences.

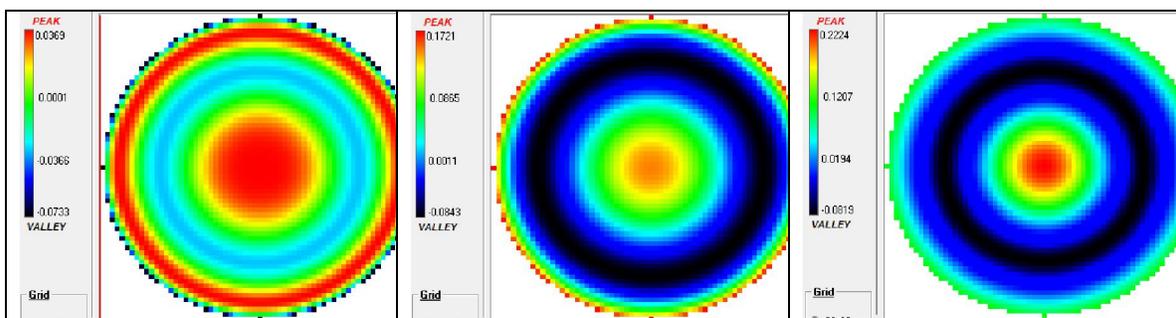
Figure 4 (iii): Graphical analysis of wavefront surface of piston rings at 60°C. The profiles illustrate the P-V aberration of the piston rings as they were subjected to thermal stress. The P-V aberration for (a) ring 1 is 69.7 nm (b) ring 2 is 162.2 nm and (c) ring 3 is 192.5 nm

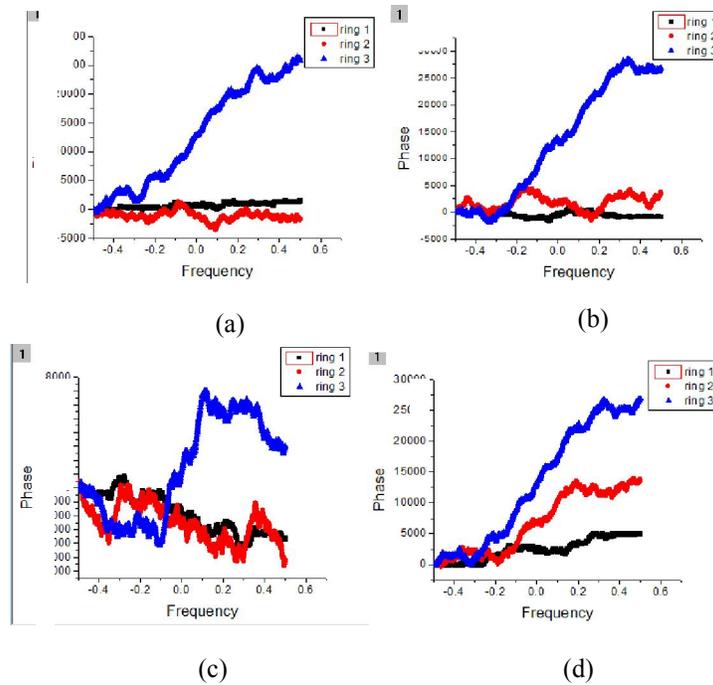
Figure 5: Piston rings interferograms phase representation with respect frequency. The graphs are arranged in order of increasing thermal stress on the rings 1, 2 and 3. (a) 25°C. (b) 40°C (c) 60°C and (d) 100°C

The phase change as a result of thermal stress was also measured from the generated interferograms. This analysis of the interferogram was done using origin version 8 software. The process of extracting the phase variation across the interferogram was undertaken using the Fast Fourier Transform (FFT) function of the software. Like any other fringe analysing technique, Fourier Fringe Analysis (FFA) extracts phase information from intensity distribution of the source fringe pattern. To retrieve the phase information from the interferogram, low pass FFT filtering was done. This was followed by shifting to eliminate the carrier frequency from the extracted phase. Since FFA uses arctangent function, it led to extraction of wrapped phase which provided discontinuous phase information. To provide the continuous phase information, unwrapping process was performed. The phase unwrapping process solves the ambiguity problem caused by the fact that the absolute phase is wrapped into interval recovering the continuous phase information. One of the limitations associated with FFA is the frequency leakage. The frequency leakage is related to discontinuities at the end of the measurement time. Therefore reduction of the frequency leakage was necessary when working with this fringe pattern analysing technique. To minimize the frequency leakage associated with FFA, the fringe patterns were multiplied by hamming window for smoothing. The window reduced the discontinuities at the end of the signal measurement. This was attained by reducing the signal to zero at the end point.

From the plots, the phase change for the three piston rings is illustrated. The change in phase for the three piston rings was observed to be nonlinear as temperature varied. At certain temperatures the change in phase of the piston rings had almost the same trend. This phenomenon was observed with piston ring 1 and 2 at temperatures of 300C and 600C. Though the trend was almost the same on

considering certain frequency value there were variation of phase values. Similarly at certain temperatures, the phase changes between the rings were diverse. This diversity in phase change is clearly noted at temperatures of 800C and 1000C. This implies that the rings were affected differently by the same thermal load. This unique piston rings behavior clearly demonstrated how the piston rings are fabricated differently to perform their task. These include; sealing of combustion chamber, regulating oil consumption, stabilize the piston and heat transfer. These tasks leads to subjecting the piston rings to stress hence they are designed to maintain their function as the environment changes.
