Erosion Risk Mapping Using CORINE Methodology for Goz Watershed in Kahramanmaras Region, Turkey

ABSTRACT

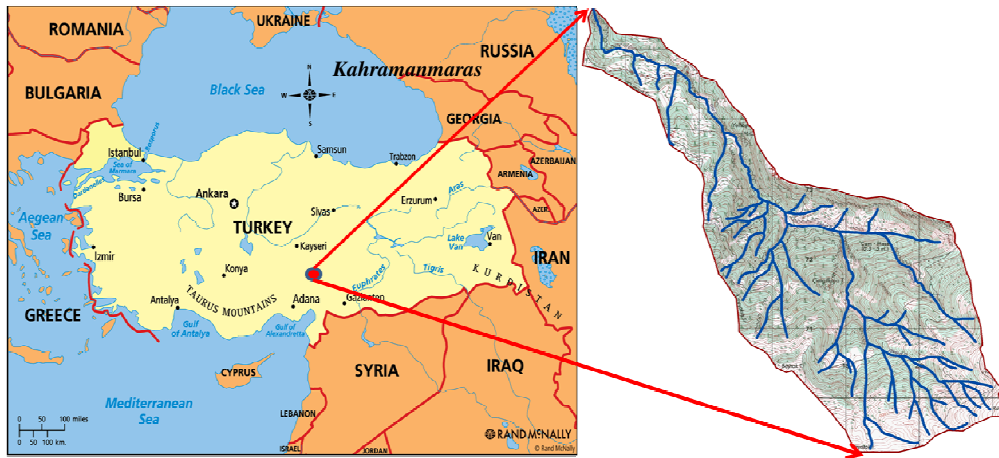
Figure 1. Goz Watershed of Menzelet Dam in Kahramanmaraş.

Goz Watershed, a sub-watershed of Menzelet Dam was selected as the study area. The watershed is 45 km away from the city of Kahramanmaras and has an area of 1,336.6 ha (Figure 1). It is located between the latitudes of 37° 39' 58" and 36° 40' 54" North, and the longitudes of 36° 54' 28" and 36° 57' 59" East. The average elevation and ground slope was 1,295 m and 38%, respectively.

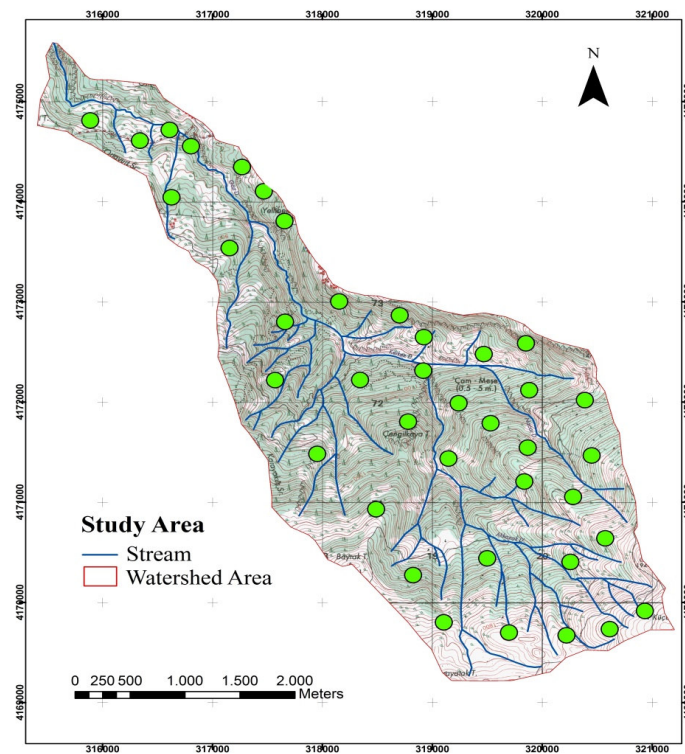
Figure 2. Soil sampling points in the study area.

Figure 2 indicates the soil sampling points in the study area. Then, only those soils that passed through a 2 mm sieve were evaluated in laboratory. Soil texture class map was interpolated with “Thiessen Polygon” for the whole watershed. Soil texture classification was made according to USDA texture classification (SSM, 1993).

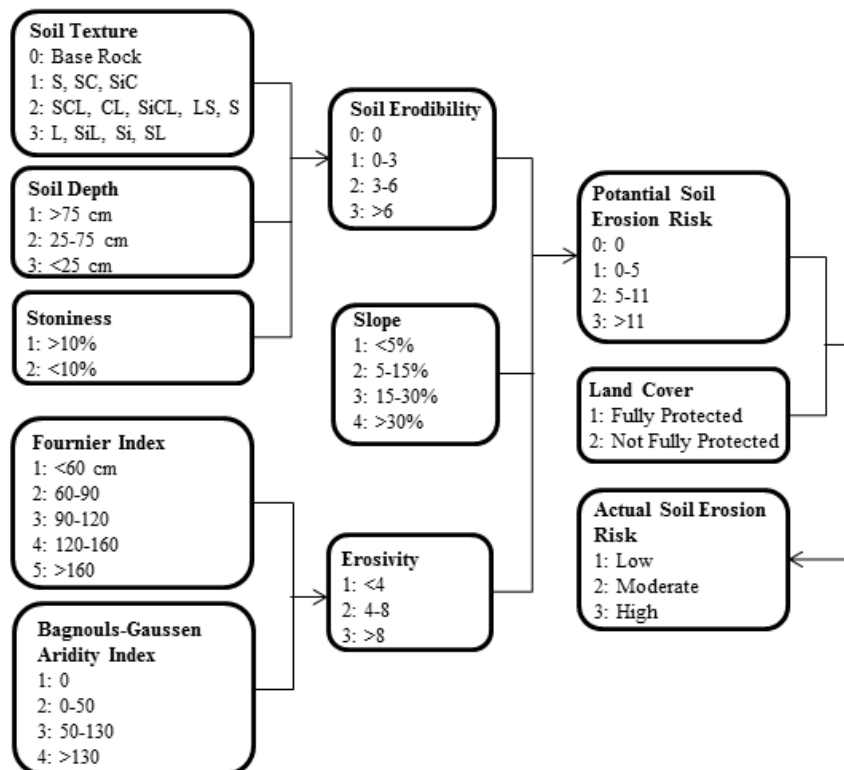
Figure 3. Flow diagram of the CORINE methodology (C: Clay; S: Sandy; Si: Silt, L: Loam).

In the CORINE methodology, soil texture was grouped into three classes including: Slightly erodible (1), Moderately erodible (2), and Highly erodible (3) (Figure 3). Soil maps were used in order to classify soil stoniness and soil depth, which are important indicators of erosion. The stoniness was classified as: Fully protected (1), and Not fully protected (2) soils, by considering the percentage surface cover of stones. The soil depth, which is the depth from the soil surface to the base of the soil profile, was classified as slightly erodible (>75 cm) (1), moderately erodible (25-75 cm) (2), and highly erodible (<25 cm) (3) soils. Finally, the soil erodibility index was calculated by multiplying these three soil factors (CORINE, 1992; Bayramin *et al.*, 2003; Aydın and Tecimen, 2010) and reclassified

Where, T_i is the mean temperature for the month, P_i is the total precipitation for month, and k_i is the proportion of the month during which $2T_i - P_i > 0$. The *BGI* was classified into: Humid (1), Moist (2), Dry (3), and Very dry (4). Finally, erosivity index was determined by multiplying Fournier and Bagnouls-Gausson aridity indices. The input data of precipitation and temperature were obtained from the nearest weather station in Kahramanmaras for the period of 1985-2010. Finally, erosivity index was reclassified into: Low (1), Moderate (2), and High (3) (Figure 3).

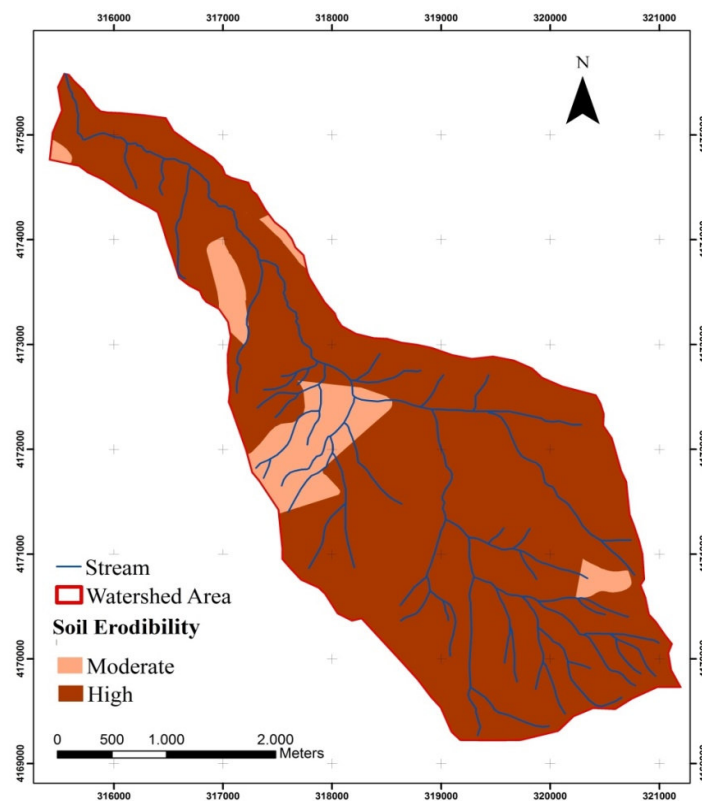
Figure 4. The soil erodibility map of the study area.

Based on soil texture, stoniness, and depth parameters, erodibility factor was moderate (3-6) in 9.5% (126.81 ha) of the total area while it was classified as high (> 6) in 90.5% (1207.98 ha) of the area. Thus, the soil in most parts of the study area was subject to erosion risk considering soil erodibility factor (Figure 4).

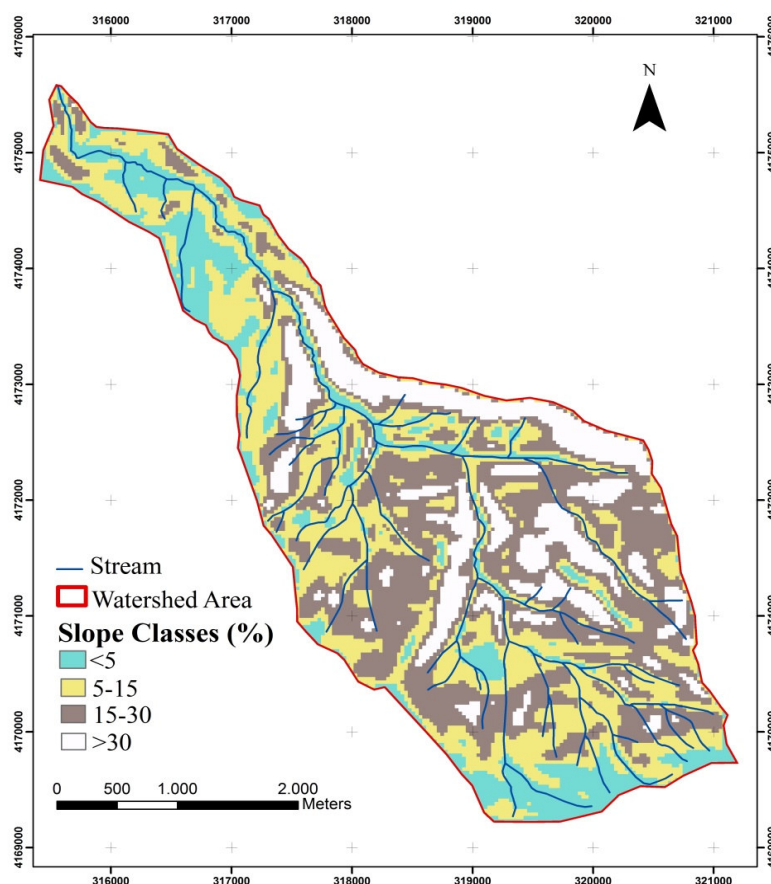
Figure 5. The slope classes map of the study area.

The topographic factors, especially ground slope, are important in terms of estimating erosion. The steep ground slope potentially accelerates the surface runoff, which dramatically increases erosion (Lal, 1994). The results indicated that the average slope in Goz Watershed was 38%. It was estimated that about 50.42% of the watershed was classified as steep and very steep areas, while the rest was on gentle slope (29.52%) and flat (20.06%) (Figure 5).

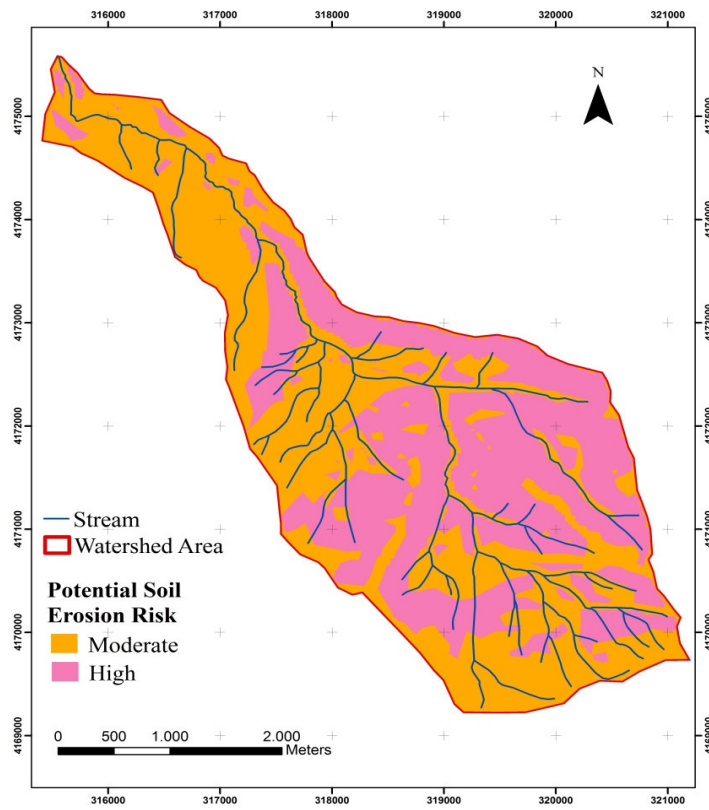
Figure 6. The potential erosion risk map of the study area.

The potential soil erosion risk of the study area was determined and then mapped (Figure 6). The potential erosion risk map indicated that the study area had 54.52% moderate and 45.48% high erosion risk levels. The actual erosion risk map was generated by overlaying potential erosion risk map and land cover map (Figure 7). Reliability of land cover data is very important in soil erosion models (Oduro-Afriye, 1996). The accuracy assessment of

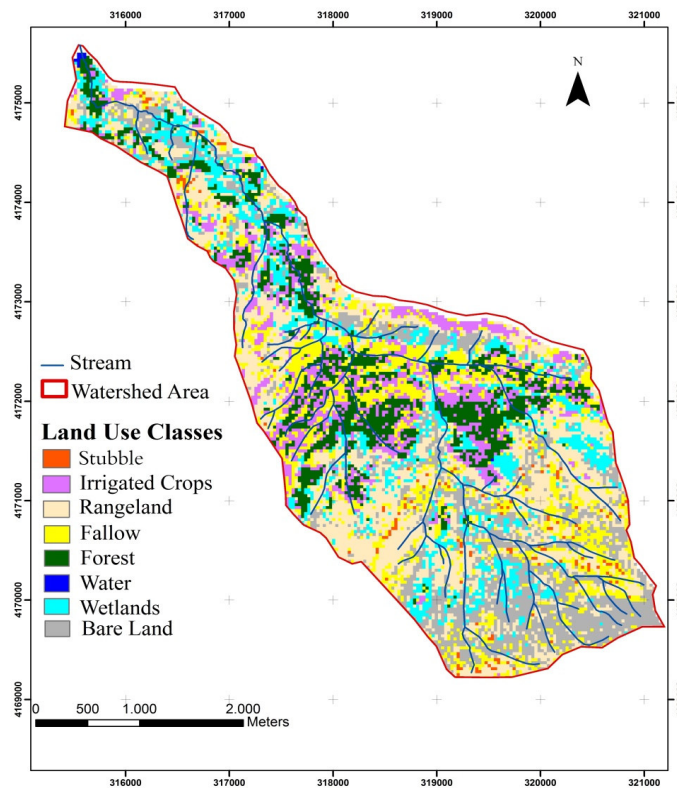
Figure 7. Land use map of the study area.

In the study area, forest was classified as fully protected (1), while the rest i.e. irrigated crops, stubble, fallow, wetlands, rangeland, and bare land were classified as not-fully protected (2). Land cover map indicated that the study area was 88.33% not-fully and 11.67% was fully protected. Actual erosion risk map indicated that 11.97% of the study area had moderate risk, while 88.03% of the study area possesses high erosion risk (Figure 8).

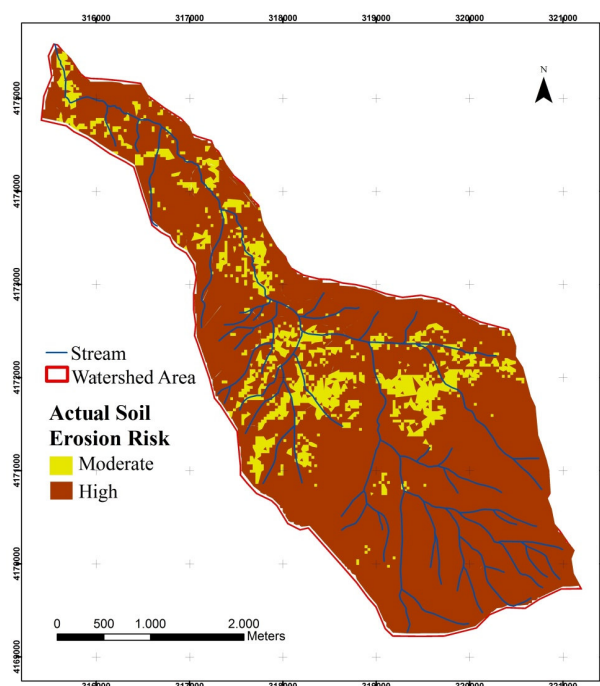
Figure 8. The actual erosion risk map of the study area.
