**ASSESSMENT OF SUSPENDED SEDIMENT LOADINGS  
AND THEIR IMPACT ON THE ENVIRONMENTAL  
FLOWS OF UPPER TRANSBOUNDARY MARA RIVER,  
KENYA**

**A thesis submitted in partial fulfillment for the degree of  
Master of Science in Soil and Water Engineering in the  
Jomo Kenyatta University of Agriculture and Technology**

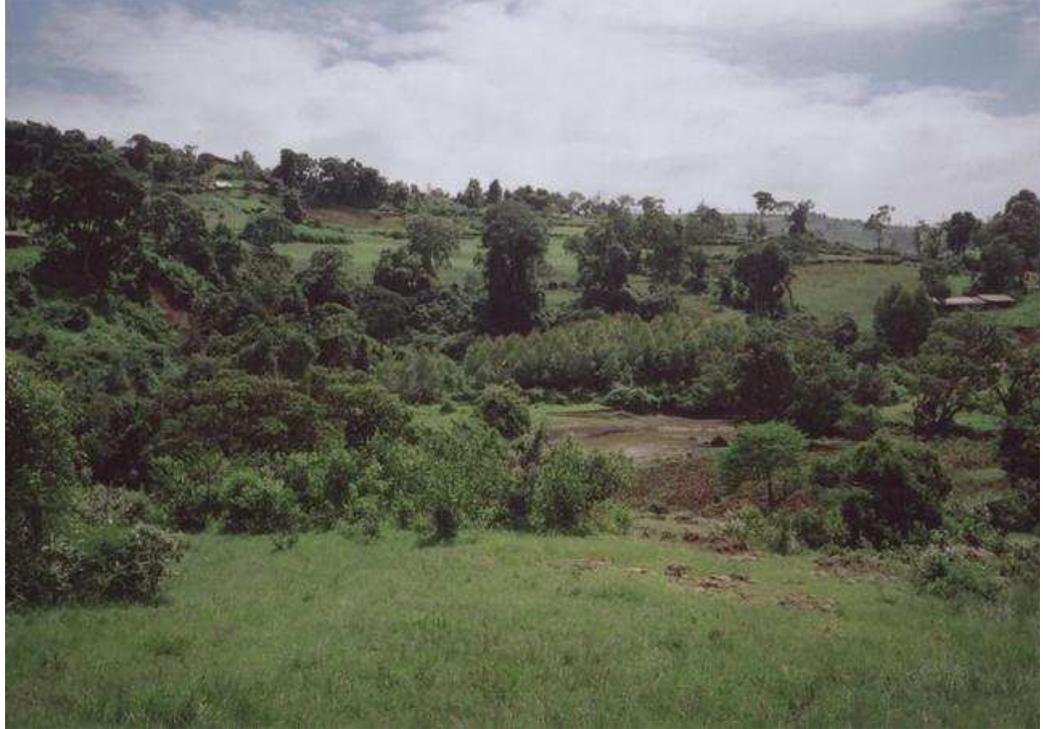
**Figure 2. 2.** Showing a new plantation of eucalyptus trees at the centre of this plate on the banks of the Amala River in the Mau forest.

eucalyptus trees have been introduced in the riparian zones (Figure 2.2) to the detriment of dry season flows. Natural vegetation is being cleared for agricultural and economic purposes.

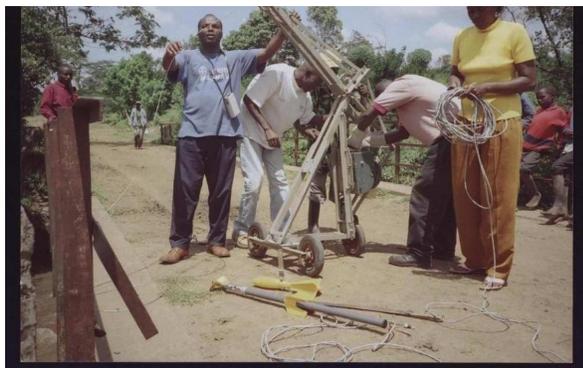
**Figure 4. 2.** Preparing a bridge crane to lower USDH-59 Sediment Sampler after current meter (in the foreground) has been used in gauging.

The three depth-integrating samplers most commonly used are the US DH-48 sampler (weight 20N) used in small streams for wading. The US DH-59 sampler is used for larger depth by suspending it by bridge crane (Figure 4.2 and 4.3) and at lower velocities and the US DH-49 sampler (weight 276N) suited for use with cable suspension system. The use of depth-integrating samplers is restricted to depths smaller than 4.5 metres (Garde and Raju, 1995).

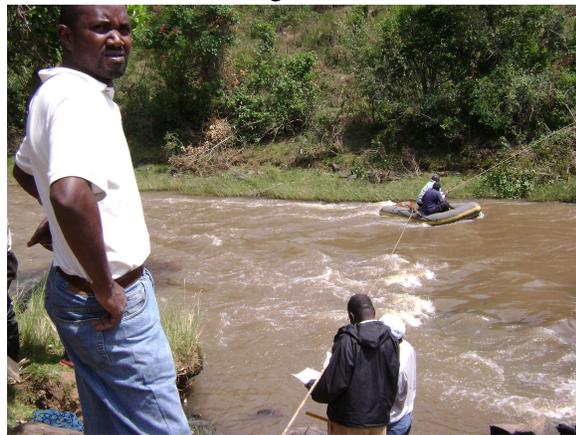
**Figure 4. 7.** Using a boat at Kapkimolwa

River flow discharges were computed from measurements of velocity and depth at a cross section near the recorder downstream of the bridge (Linsley, 1988). The mid-section method (Mutreja, 1986) of discharge calculation was used to compute discharge (equation 1). It assumes that the mean velocity for the vertical  $i$  represents the mean velocity in the cross section, from half-way to the preceding vertical ( $i-1$ ) to halfway to the next vertical ( $i+1$ ). Incremental discharge for each measurement is computed as

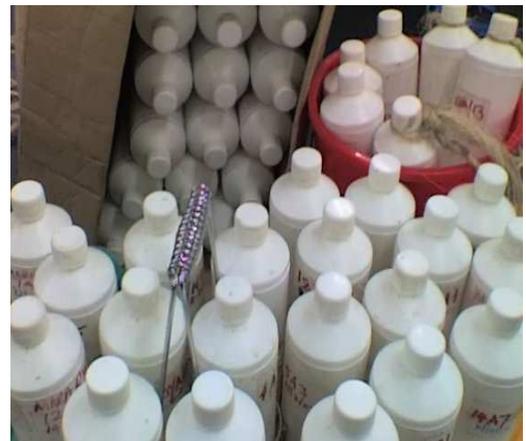
**Figure 4. 9.** 1-litre Sediment Sample bottles

All Samples for this study were transported and analysed at Jomo Kenyatta University of Agriculture and Technology for Total Suspended Solids (TSS). The frequency was

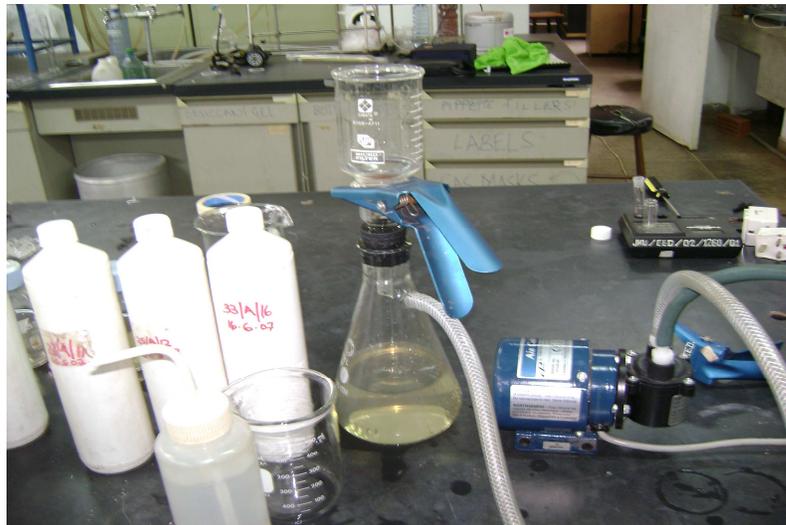
**Figure 4. 10.** Vacuum filtration apparatus for determining Total Suspended Sediment.

The concentration of suspended sediment in the water samples was determined in the laboratory using the method described in Bartram and Ballace (1996) and APHA methodology No. 2540D (A.P.H.A, 1995). The sand concentration was negligible and not required separately, so a known volume of raw water was filtered through a pre-weighed 0.45  $\mu\text{m}$  pore diameter filter paper. The 1-Litre sample was agitated and sub-sampled into 200ml and analyzed for suspended sediment concentration with a vacuum filtration apparatus as shown in Figure 4.10.

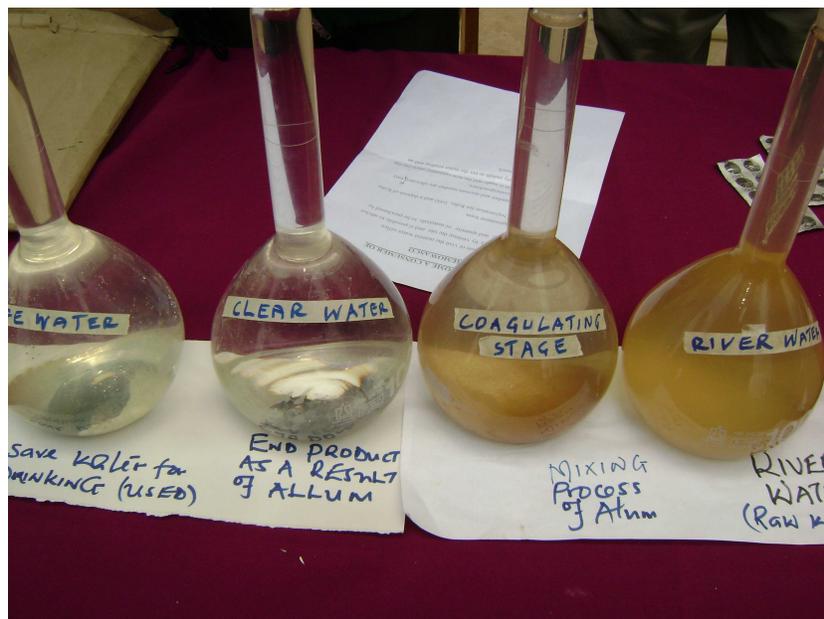
**Figure 4.11.** Water treatment to reduce the turbidity of Nyang’ores River samples.

Complete water treatment can be achieved by the addition of lime to make the water slightly alkaline, followed by the addition of coagulants like Alum (Aluminium Sulphate). Flocculation and coagulation assist in removing contaminants in the water causing turbidity, colour, odour and taste which cannot be removed by sedimentation alone. Most colours can be removed by treatment with ferric sulphate or ferric chloride. The resultant precipitate can be removed by sedimentation and filtration (Figure 4.11).

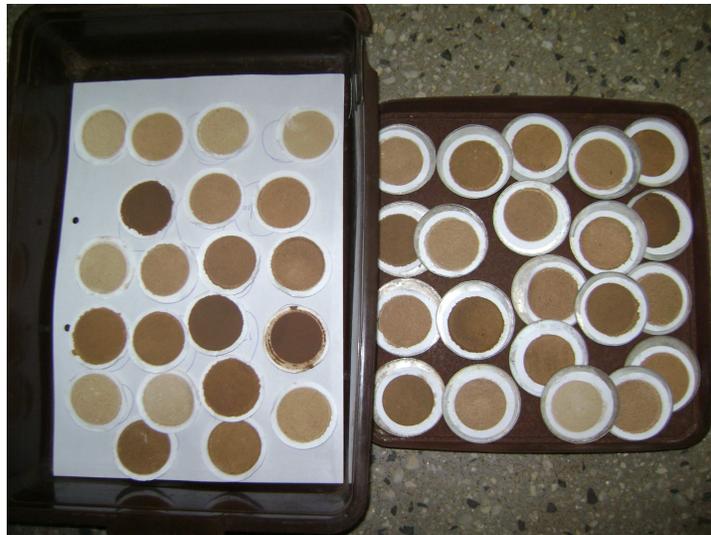
**Figure 4. 12.** Dried product samples used in X-Ray Fluorescent analysis for trace metals.

Normally, chemical analysis is performed on dry material. The concentrations of trace metals from 12 dried sediments samples after TSS analysis shown in Figure 4.12 were analyzed using an X-Ray Fluorescence spectrometer in the University of Nairobi. This is an elemental and chemical analysis for investigation of metals and building materials for research in geochemistry, forensic science and archaeology. The selection was based on the typical hysteresis effect observed in suspended sediment as described by Bartram and Ballace (1996). For each river, two dried samples were analyzed when flow increased, two when it reached a peak, and then two when it decreased.

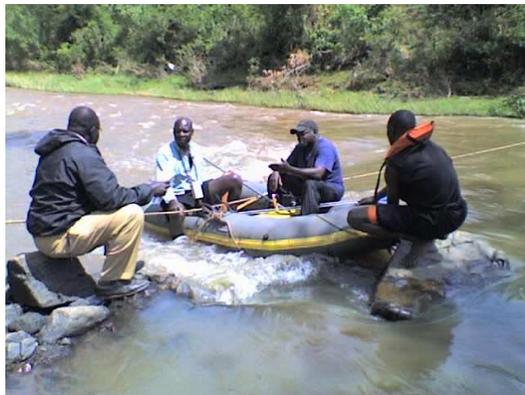
**Figure 4. 14.** Geomorphologic macro-reach 1 survey for channel pattern and flow structure at Amala river.

Site selection for environmental flow assessment (EFA) was done through geomorphological surveys that classified the river into three uniform macro-reaches based on gradient, channel pattern and bed structure. During initial field visits, a representative site for each of macro-reach was chosen. This study was done in the upper Mara catchment reach. Consultations on the site’s ability to resist disturbance and capability to recover from disturbance were held at the site or in the office (Figure 4.14 and 4.15).

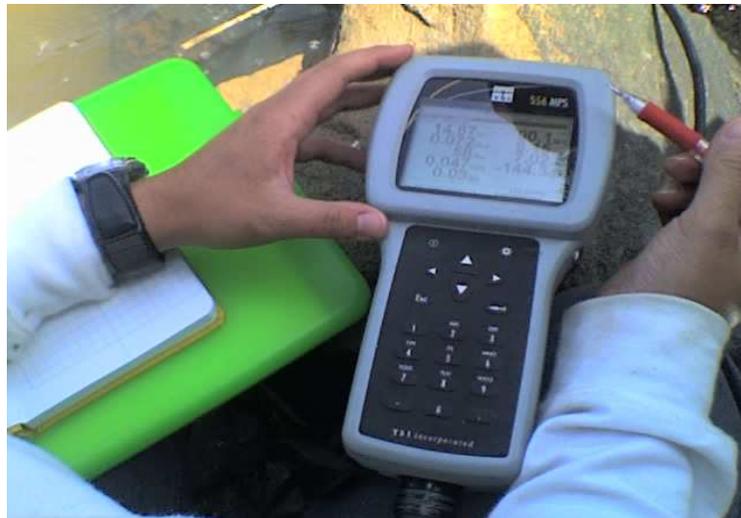
**Figure 4. 19.** Measuring various parameters using YSI 556 handheld multimeter probe.

During the EFA, other physical and chemical parameters (temperature [°C], electrical conductivity [EC], total dissolved solids [TDS], salinity, dissolved oxygen [DO] and pH) were measured on-site with an YSI 556 handheld multimeter probe shown in Figure 4.19.

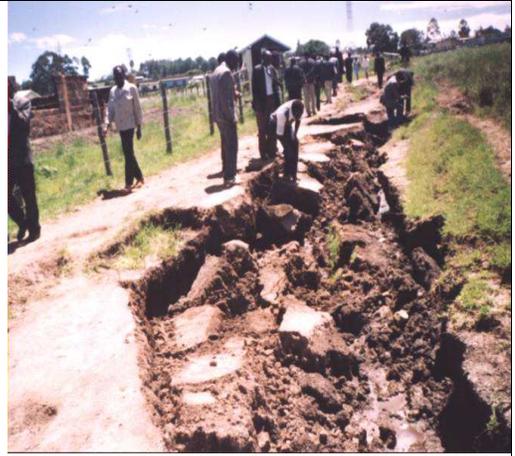
**Figure 5. 7.** Gully formation and soil erosion along access road to Bomet Town, upstream of 1LA03.

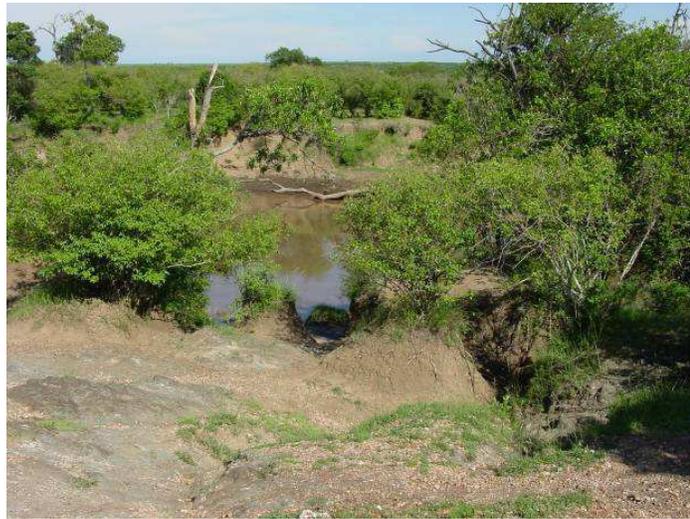
**Figure 5. 10.** Deep gullies formed along the riparian zone by human, animal and wildlife trails at Amala river.

There were many areas along the riverbank without vegetation and showing deep gullies forming along moderately trampled human and animal trails and car washing sites. There is evidence of significantly high levels of erosion along the Amala River, with the riverbank showing deep undercutting (Figure 5.10).

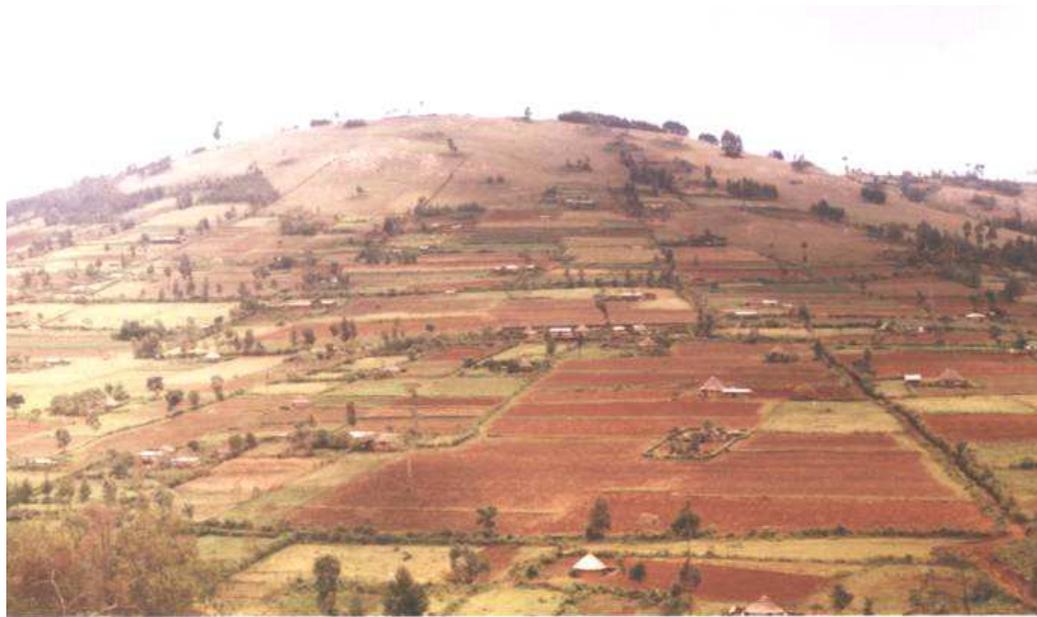
**Figure 5. 19.** Intensively cultivated and degraded area upstream of RGS at Bomet Bridge.

Emoyan *et al.* (2005) in a similar study in Nigeria, found out that iron concentration also increases during floods due to low dissolved oxygen content in the river system, in that Iron can easily be absorbed on particulate organic matter or complexes with colloidal organic matter in aquatic environment. Figure 5.19 shows that soil erosion and shopping centres upstream of the gauging sites could be the possible sources of trace metal pollution.
